iRescue 2010

Heavy Vehicle Collision

Under ride/Over ride Presentation

Incident Case Study

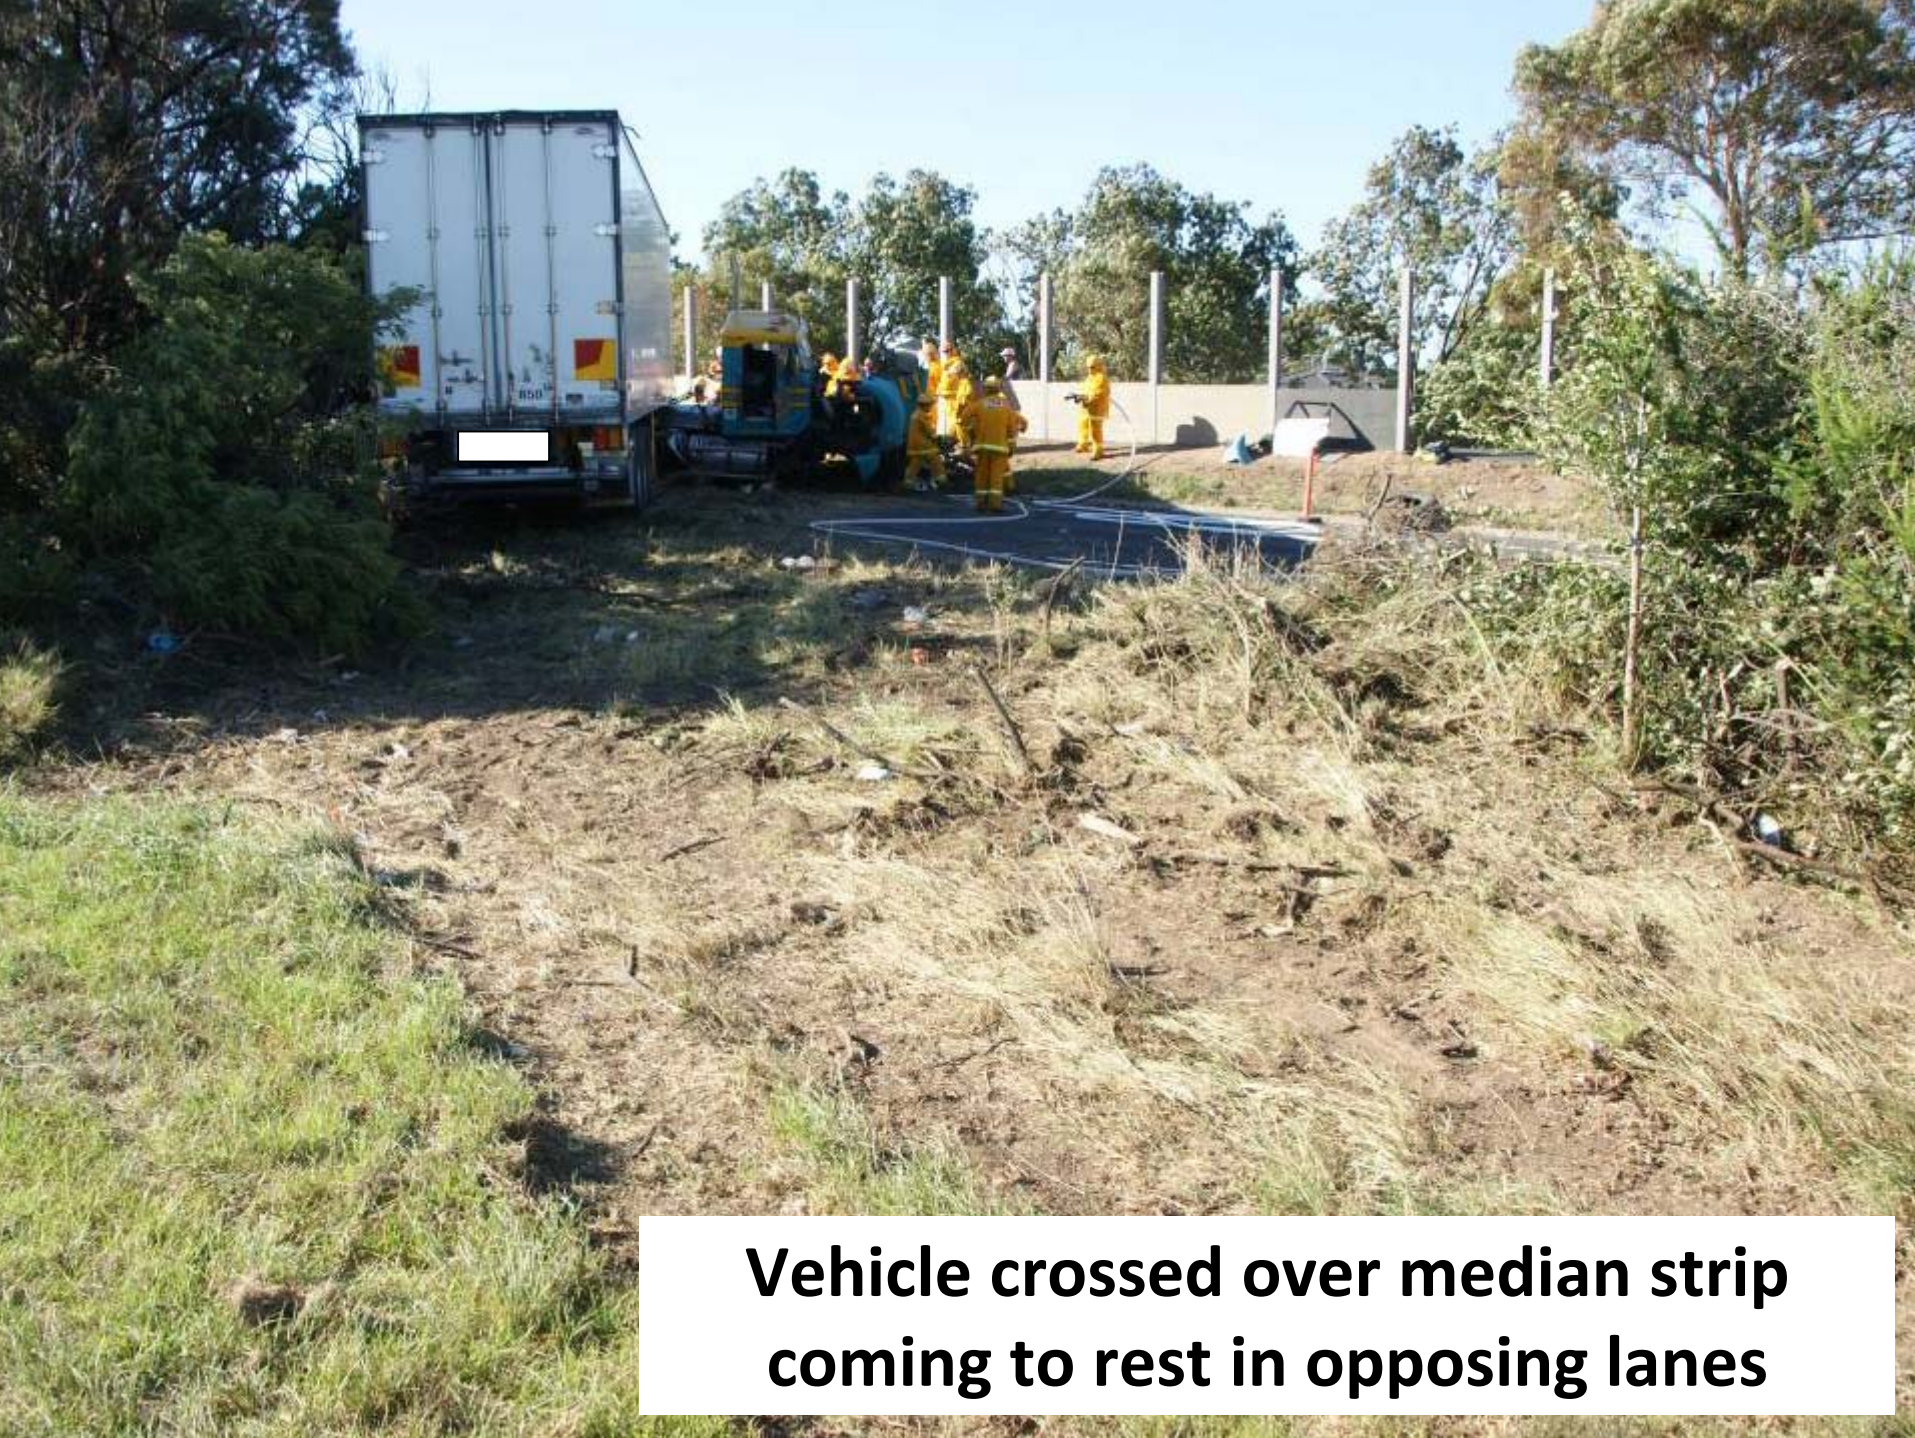
**Vehicle crossed over median strip
coming to rest in opposing lanes**

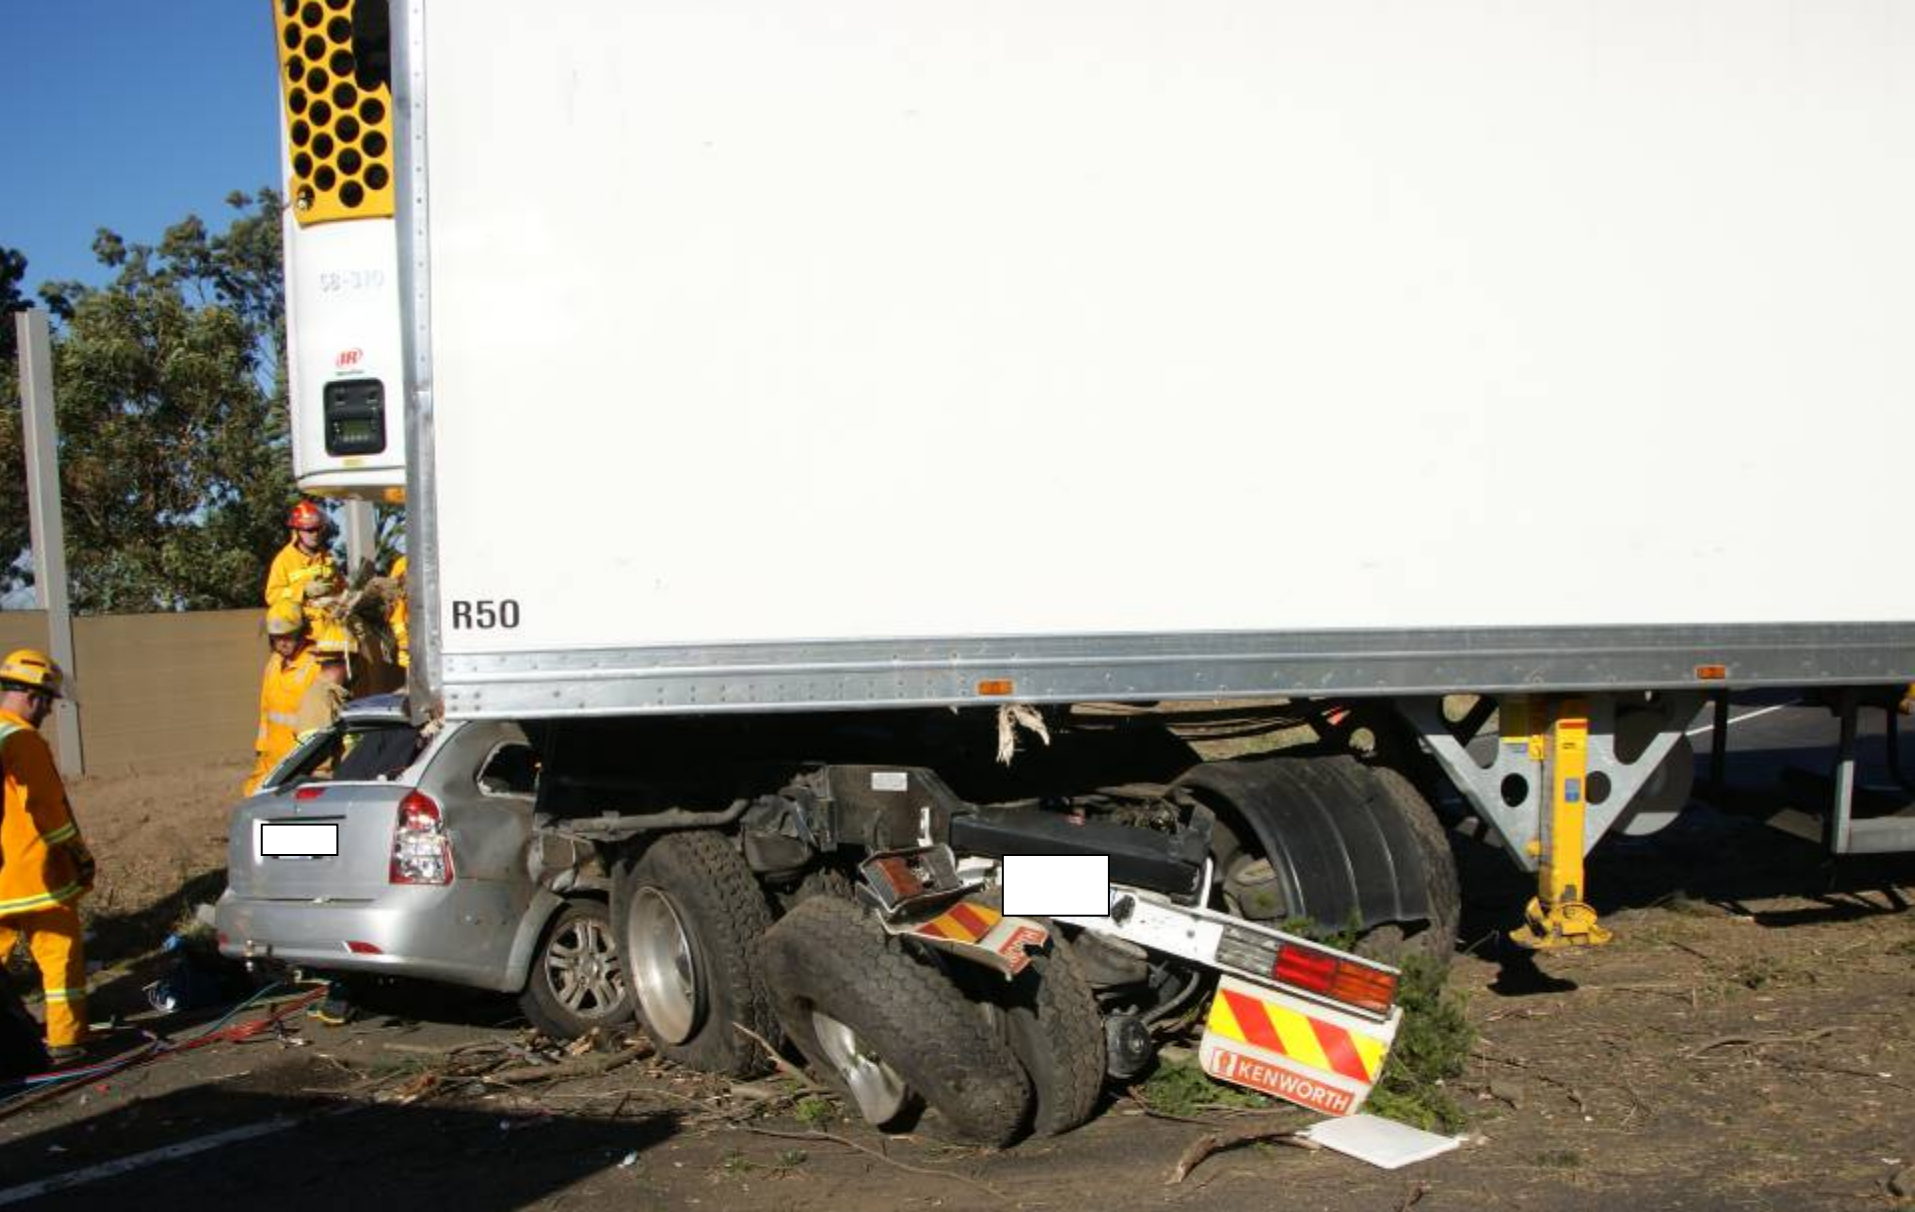
The car was well under the truck , note the truck chassis and drive wheels

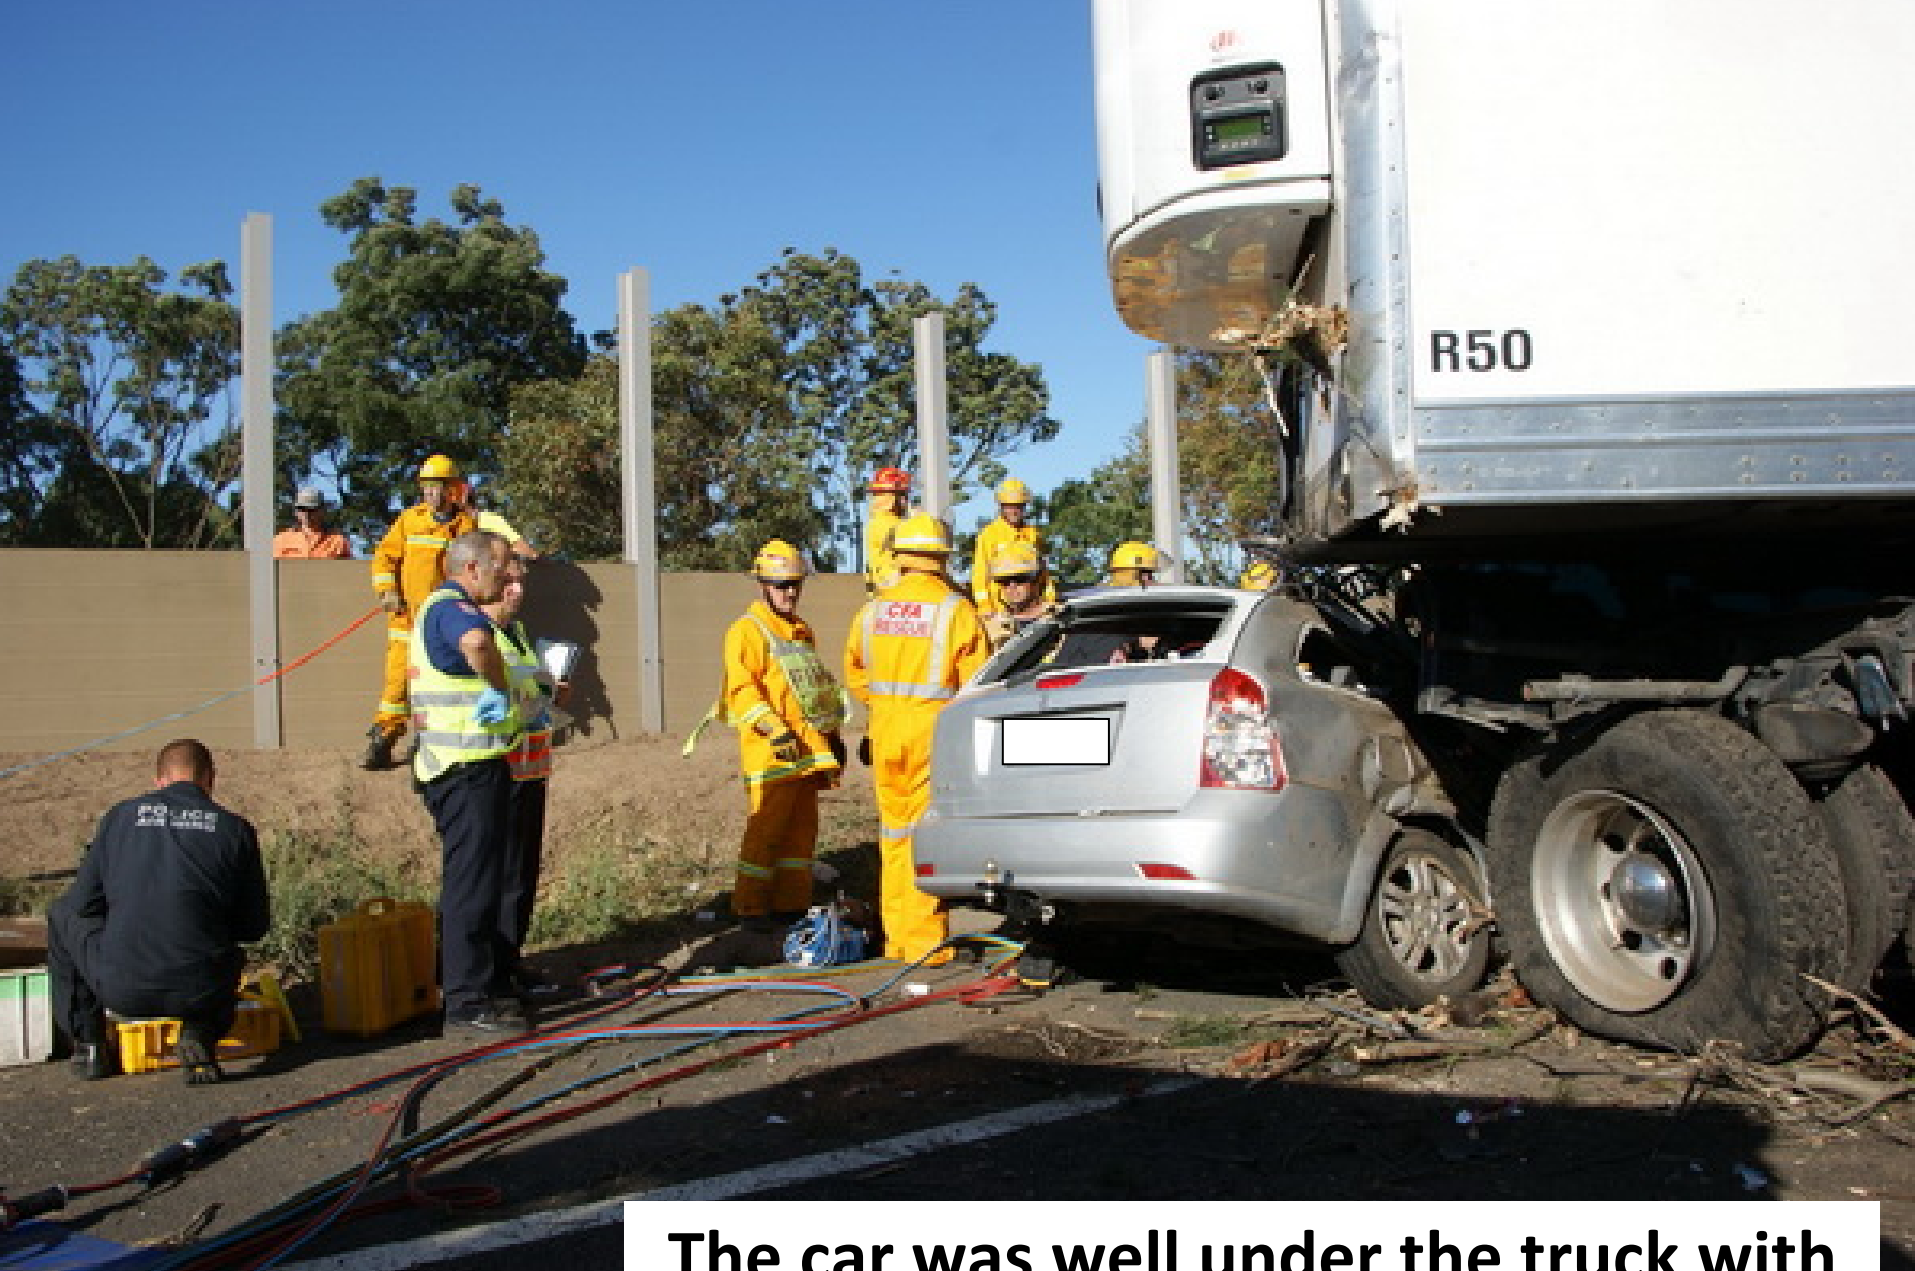
The car was well under the truck with access to the driver impeded

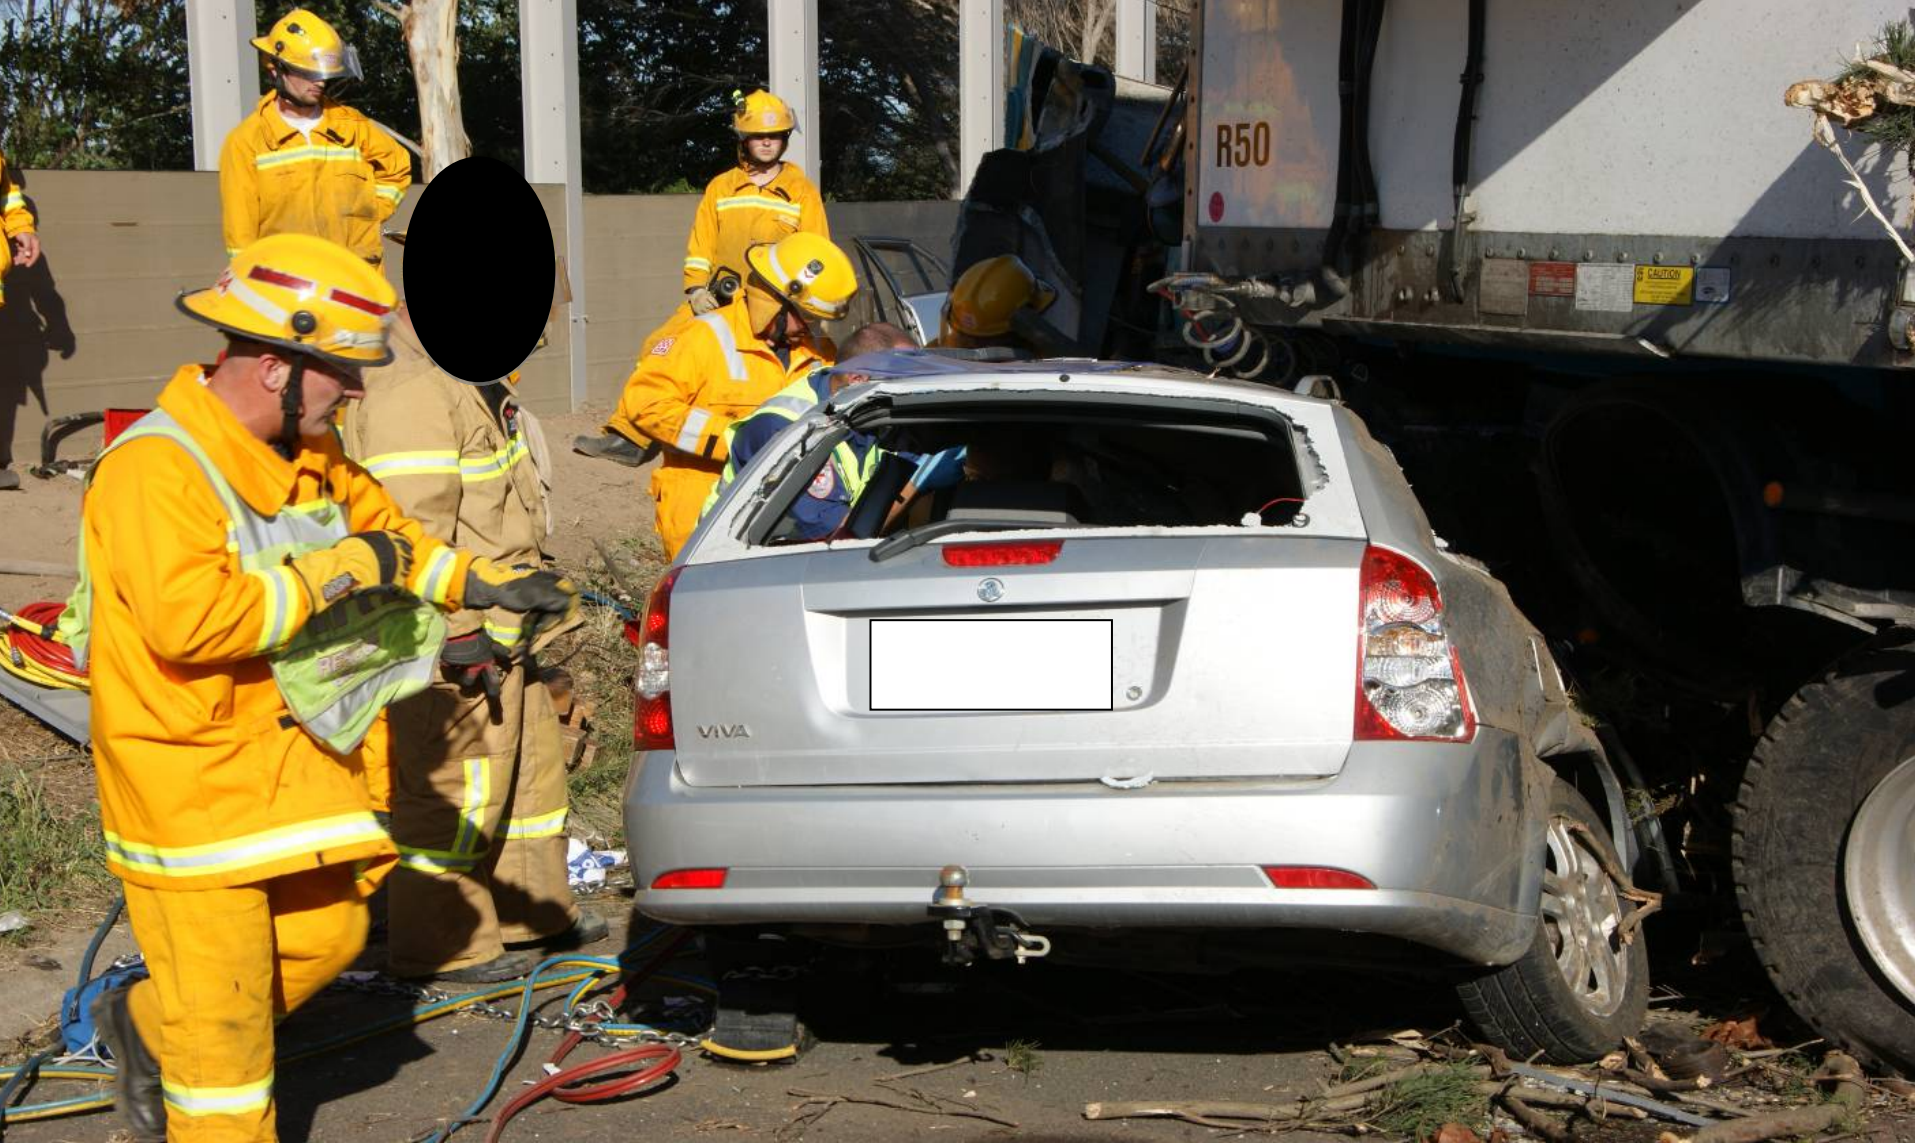
The drivers side of the car was completely inaccessible

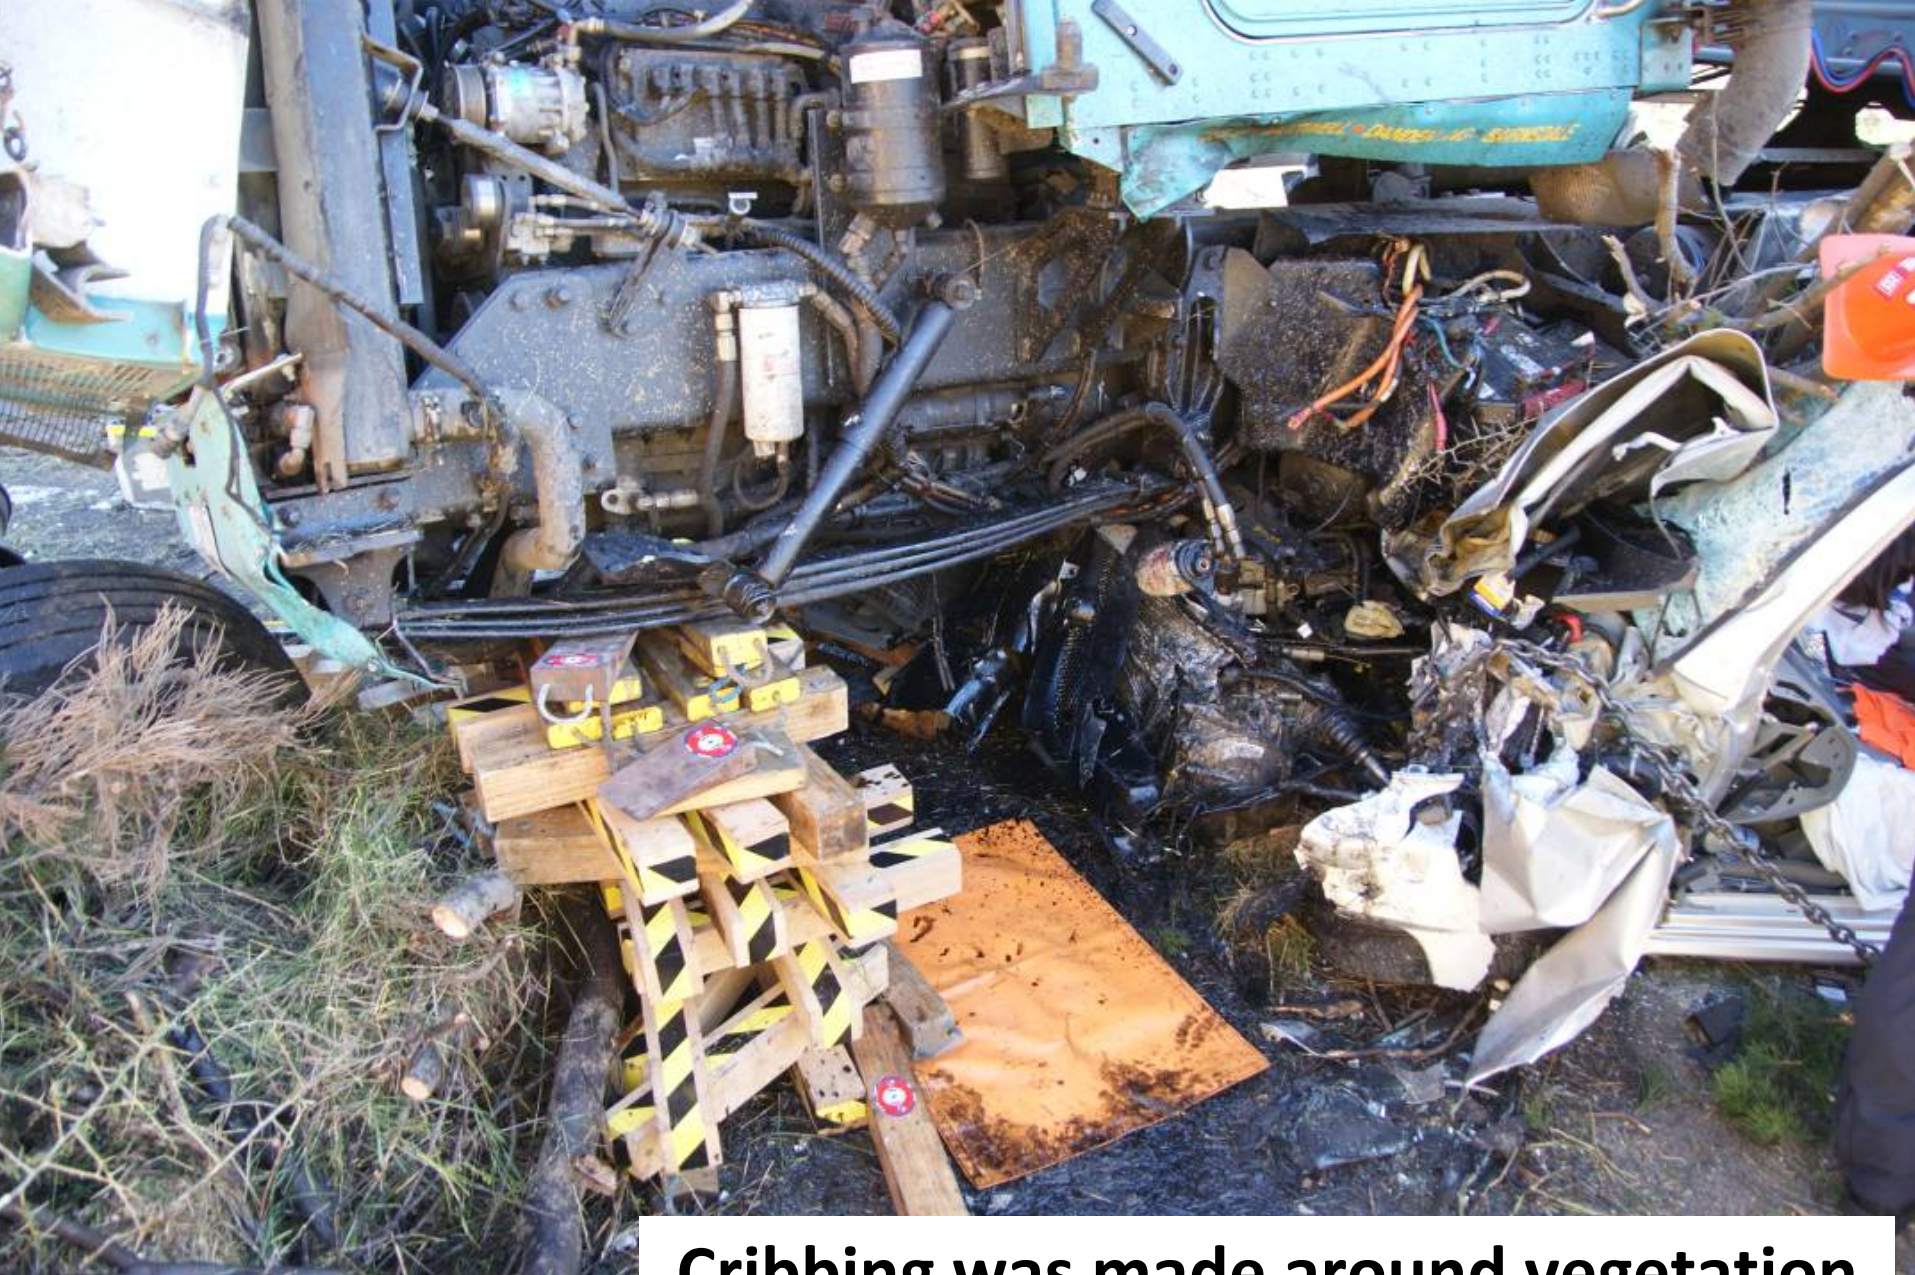
Cribbing was made around vegetation that was stuck under the truck

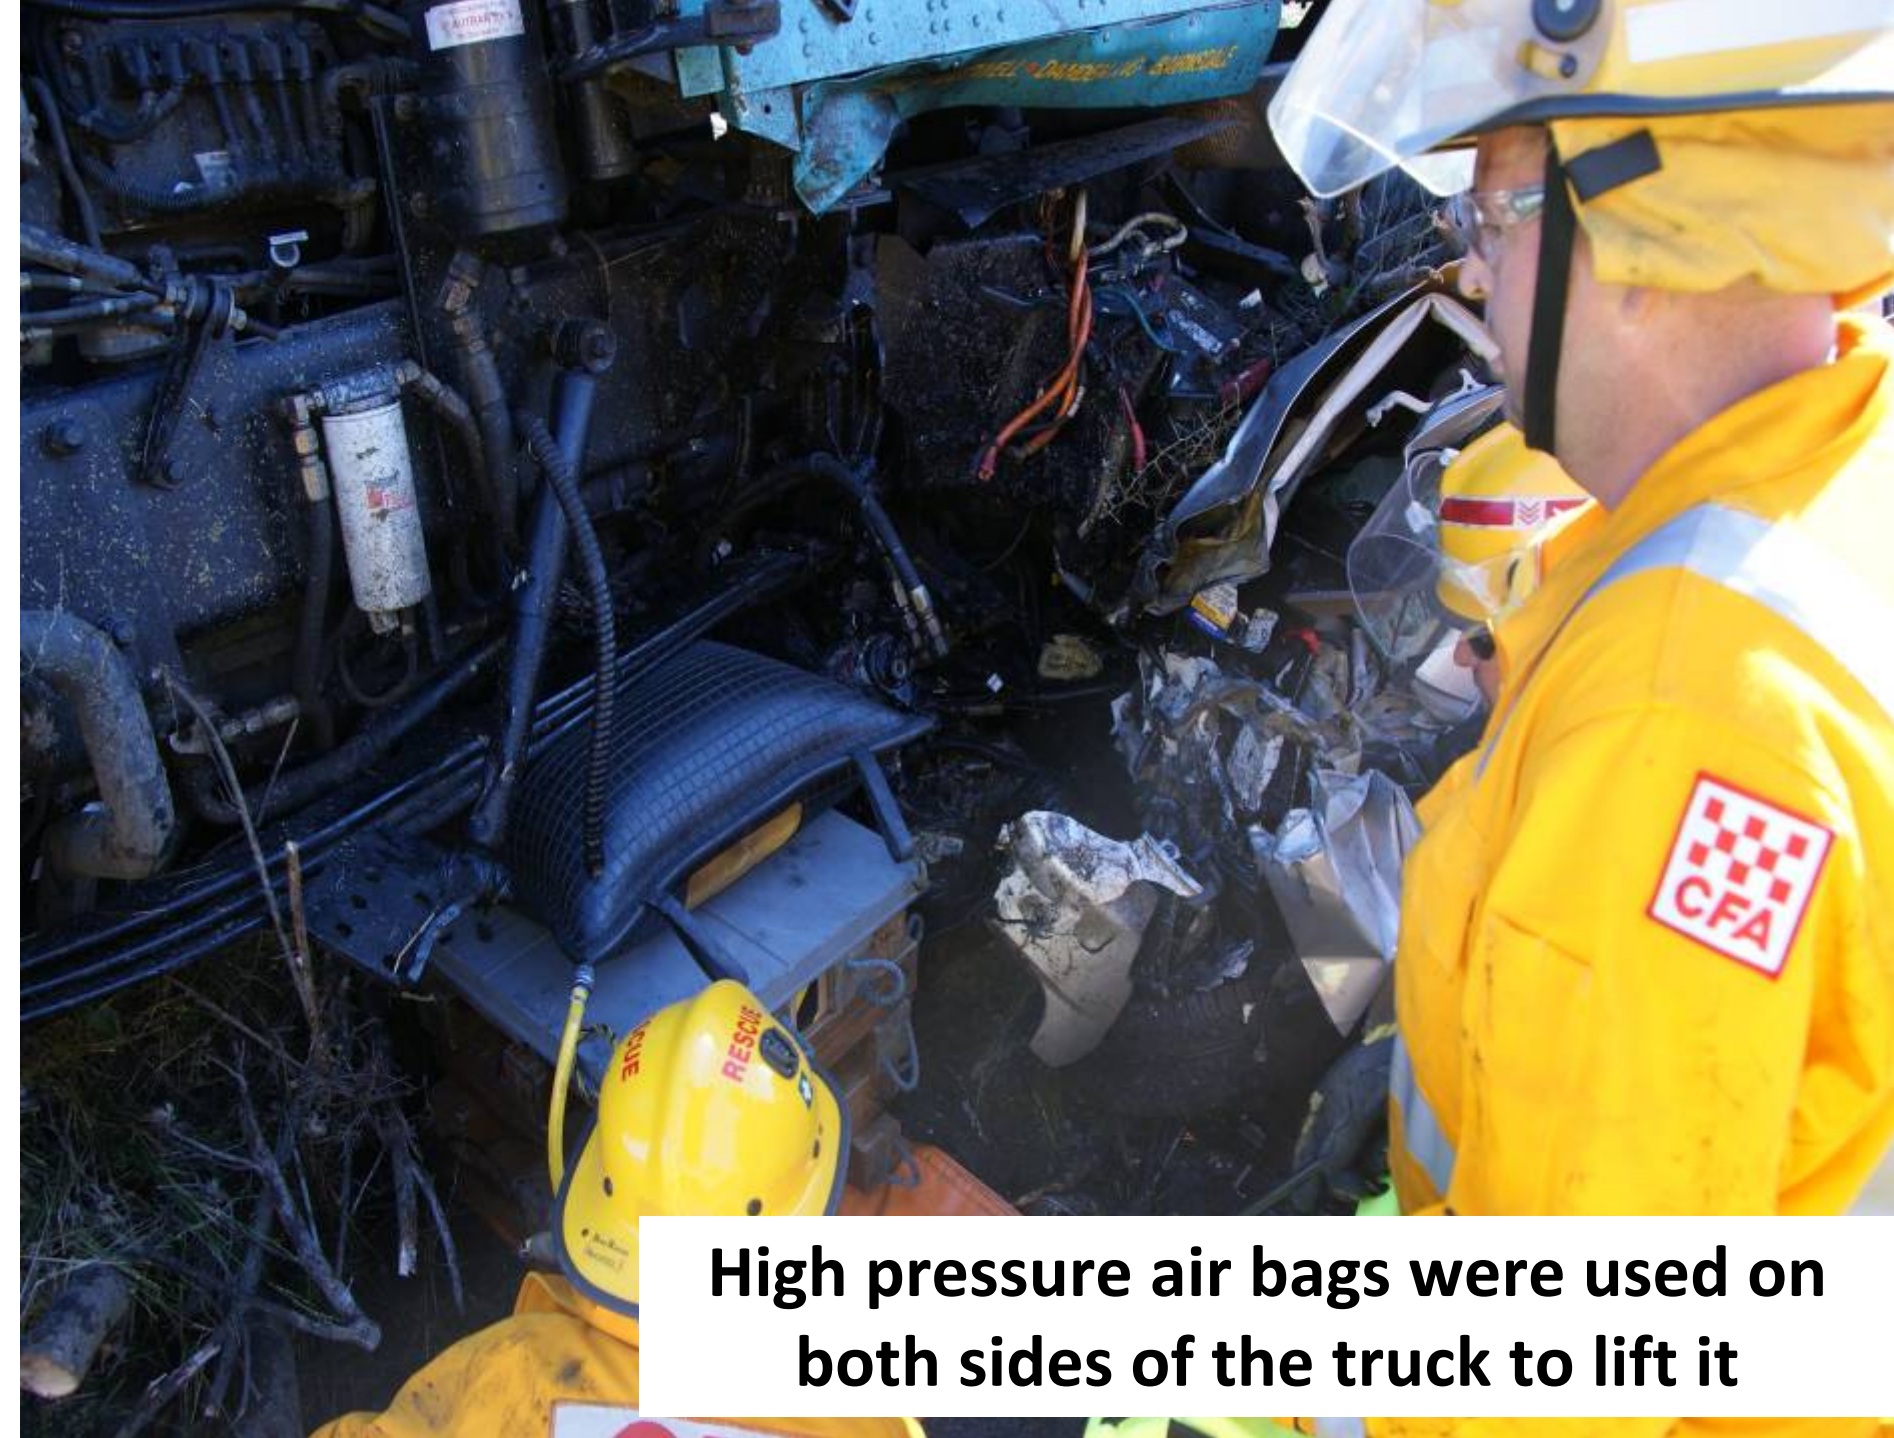
High pressure air bags were used on both sides of the truck to lift it

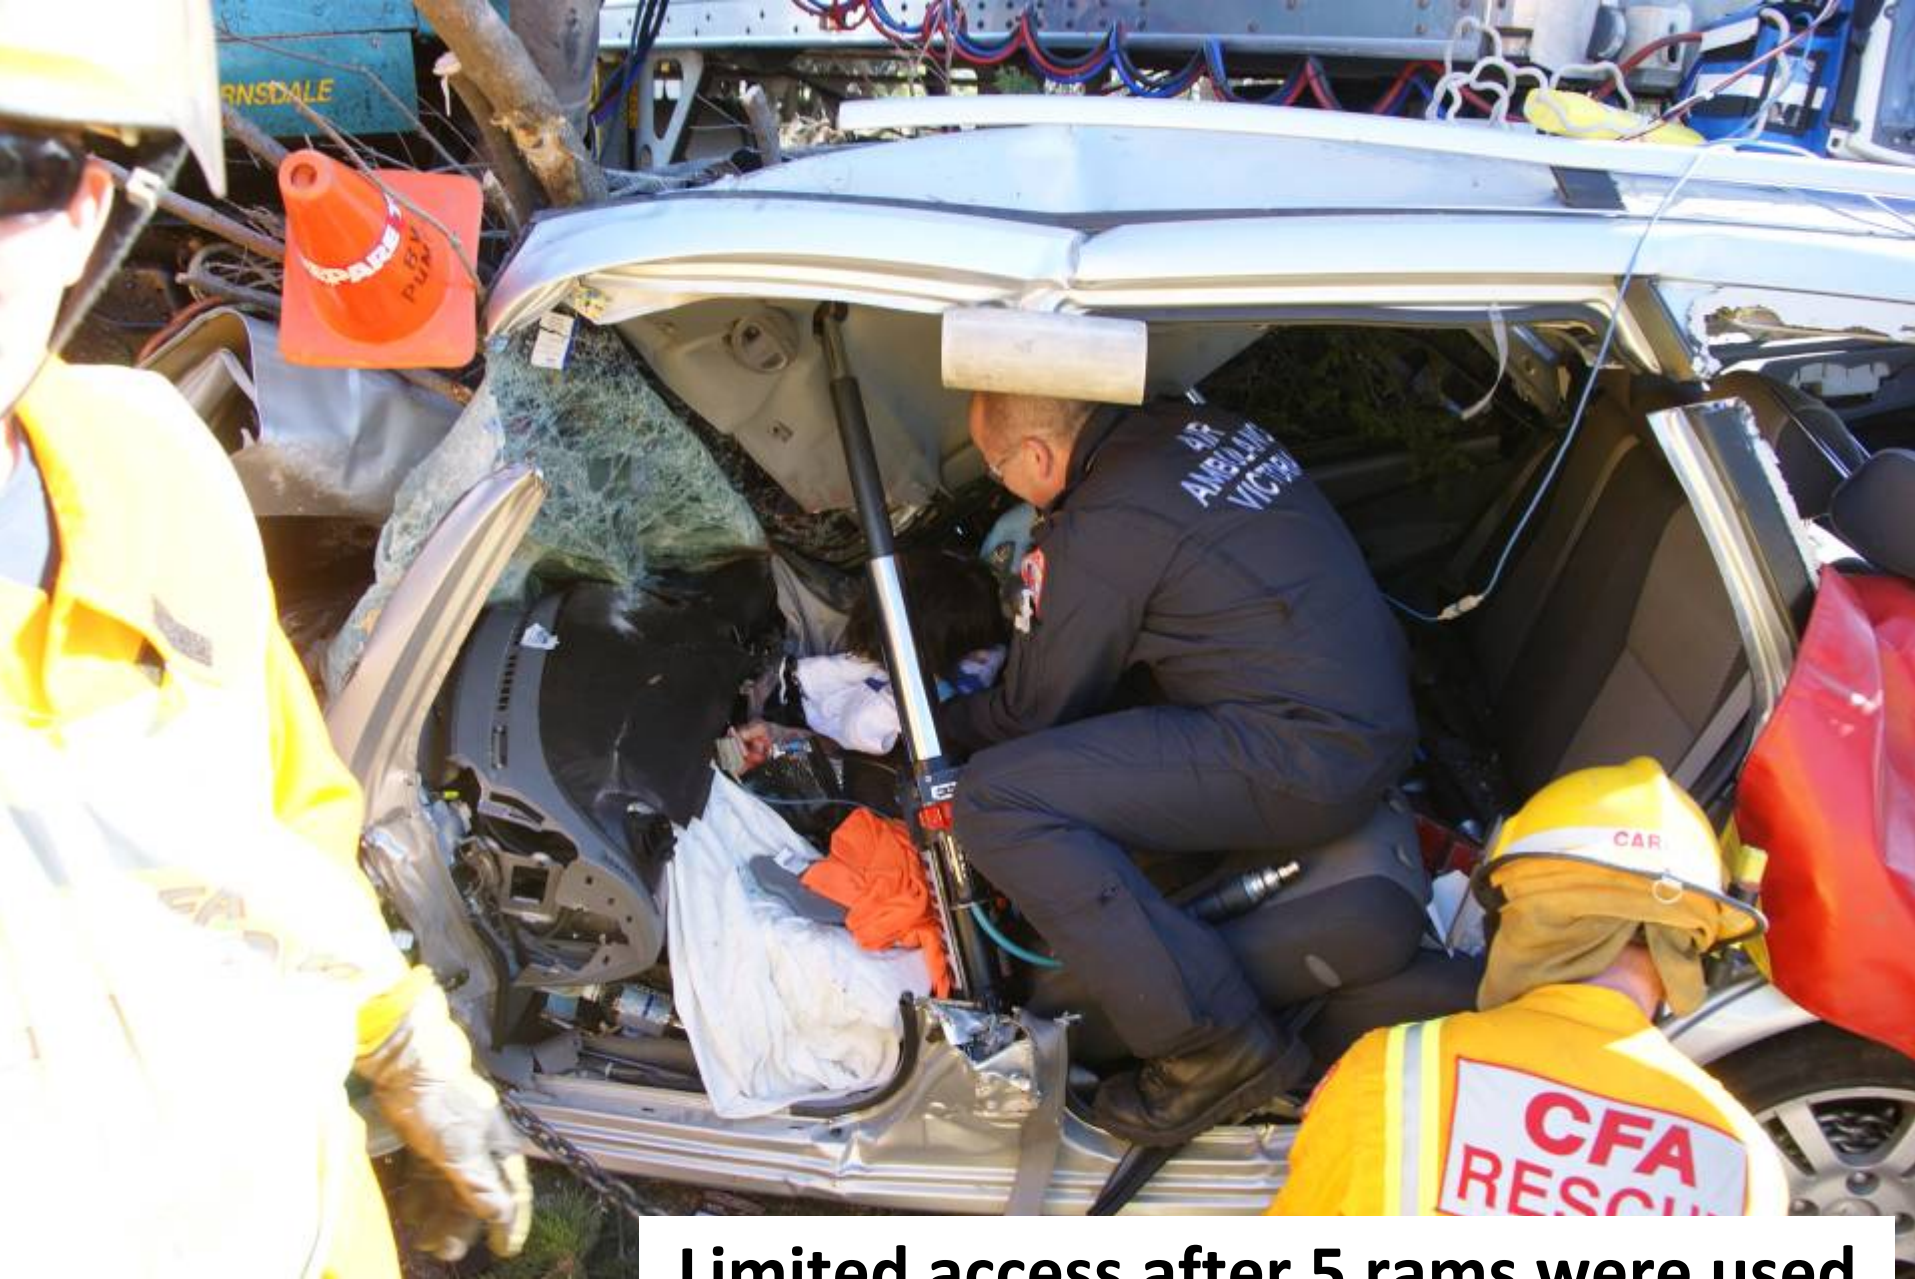
**Limited access after 5 rams were used
in the car to move the roof away**

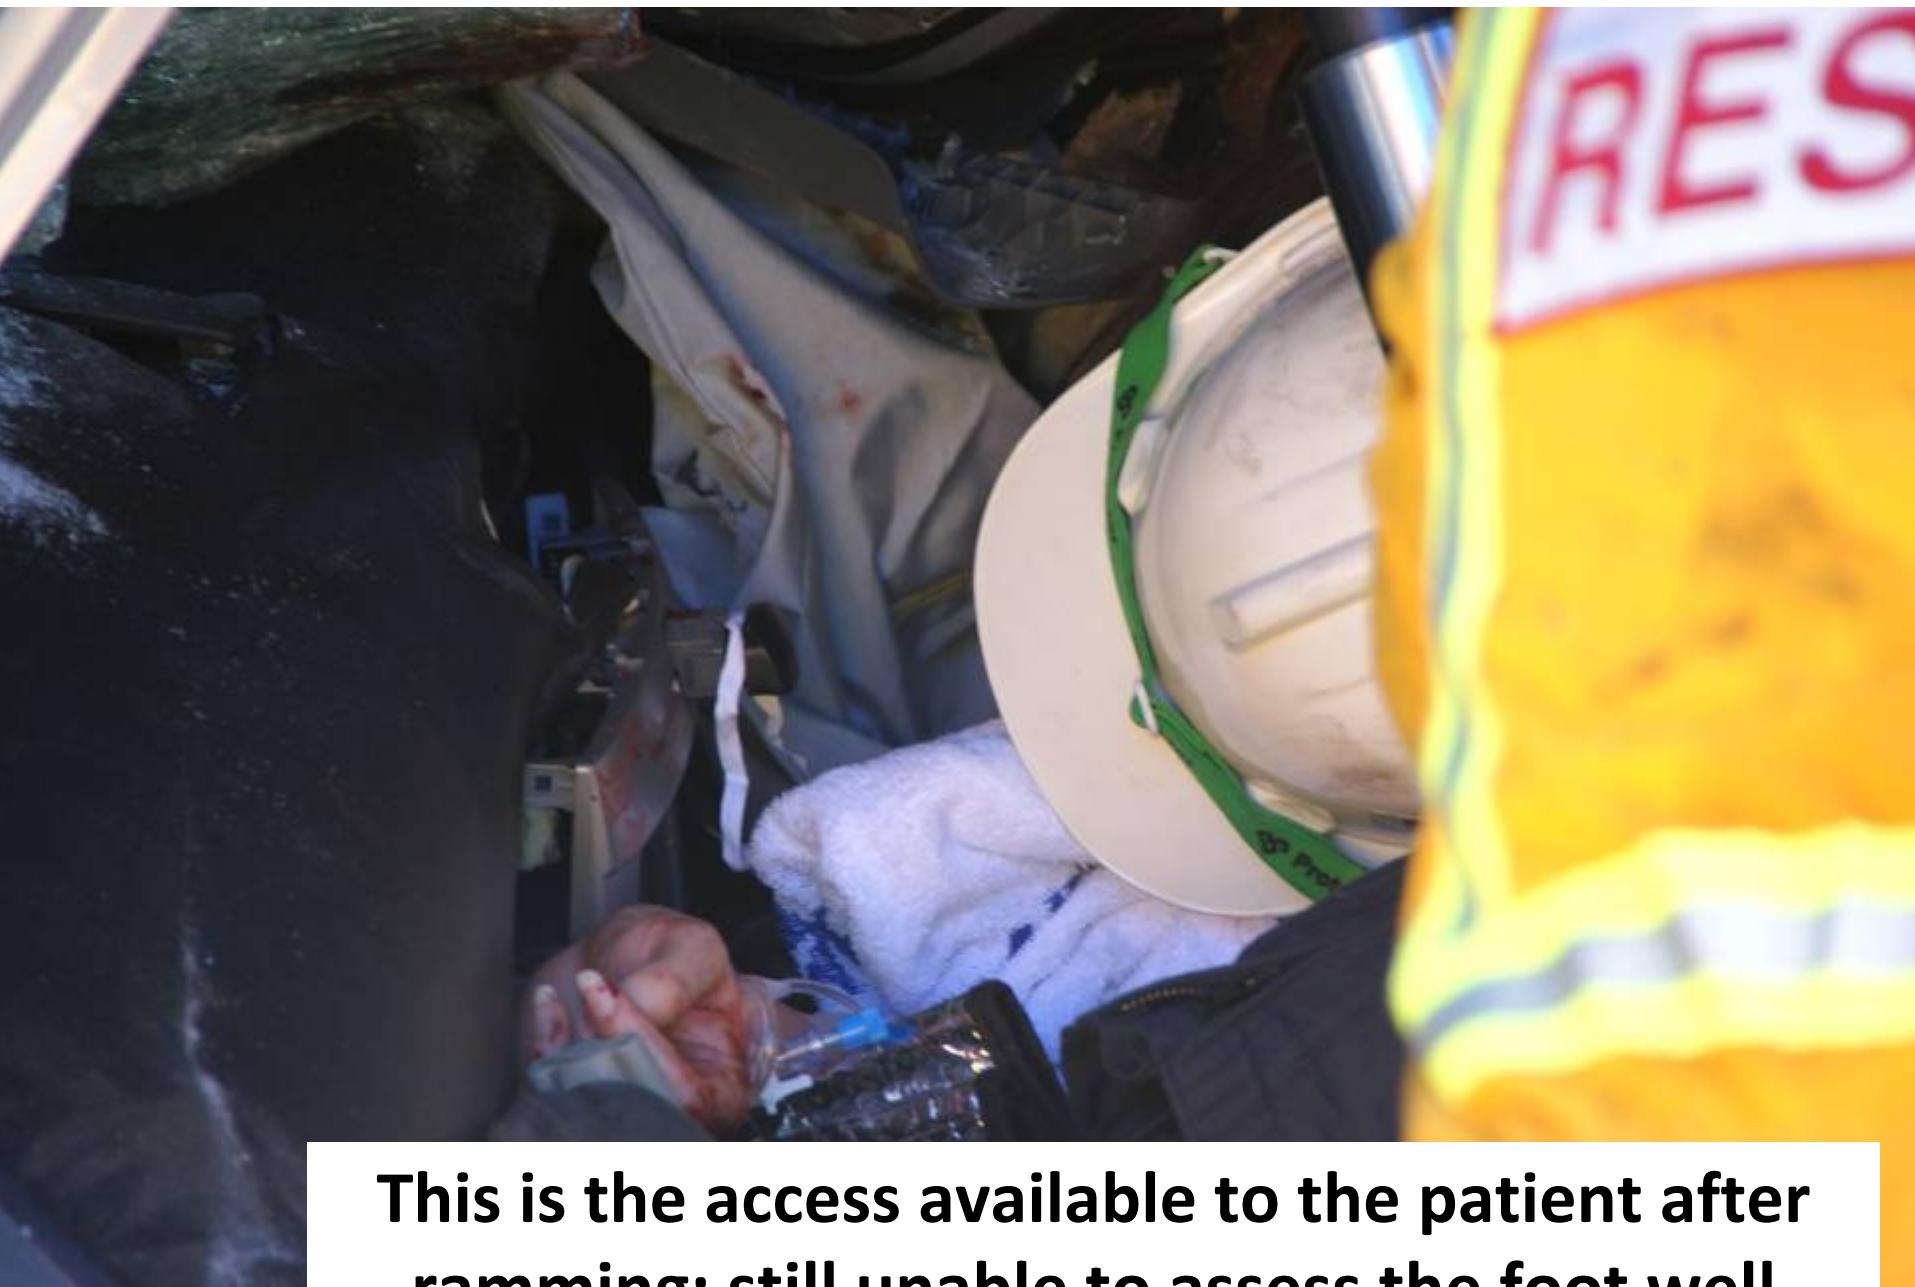
This is the access available to the patient after ramming; still unable to assess the foot well

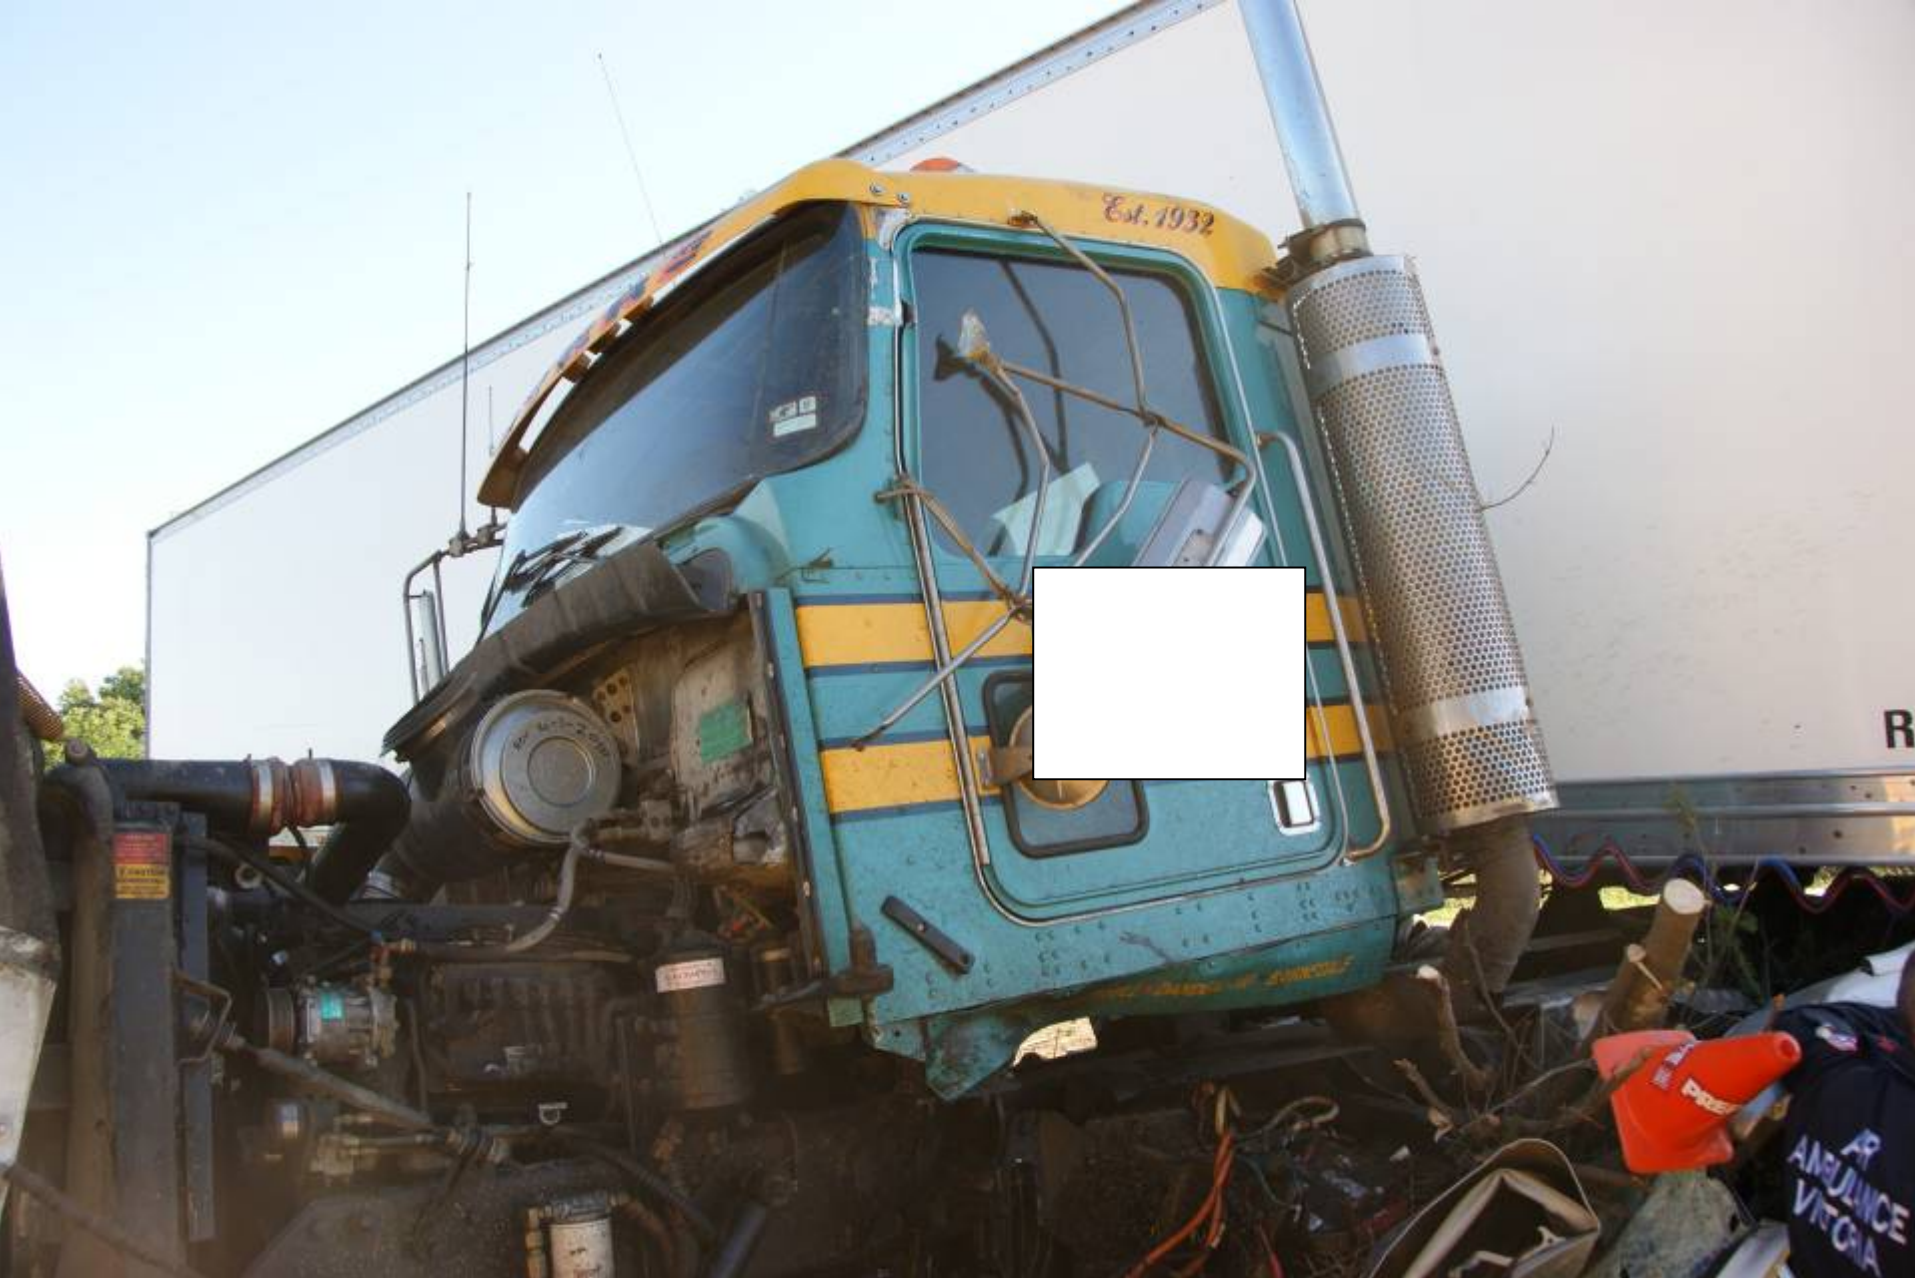
Large amounts of damage sustained by the truck
