iRescue 2010

Heavy Vehicle Collision

Under ride/Over ride Presentation

Incident Case Study

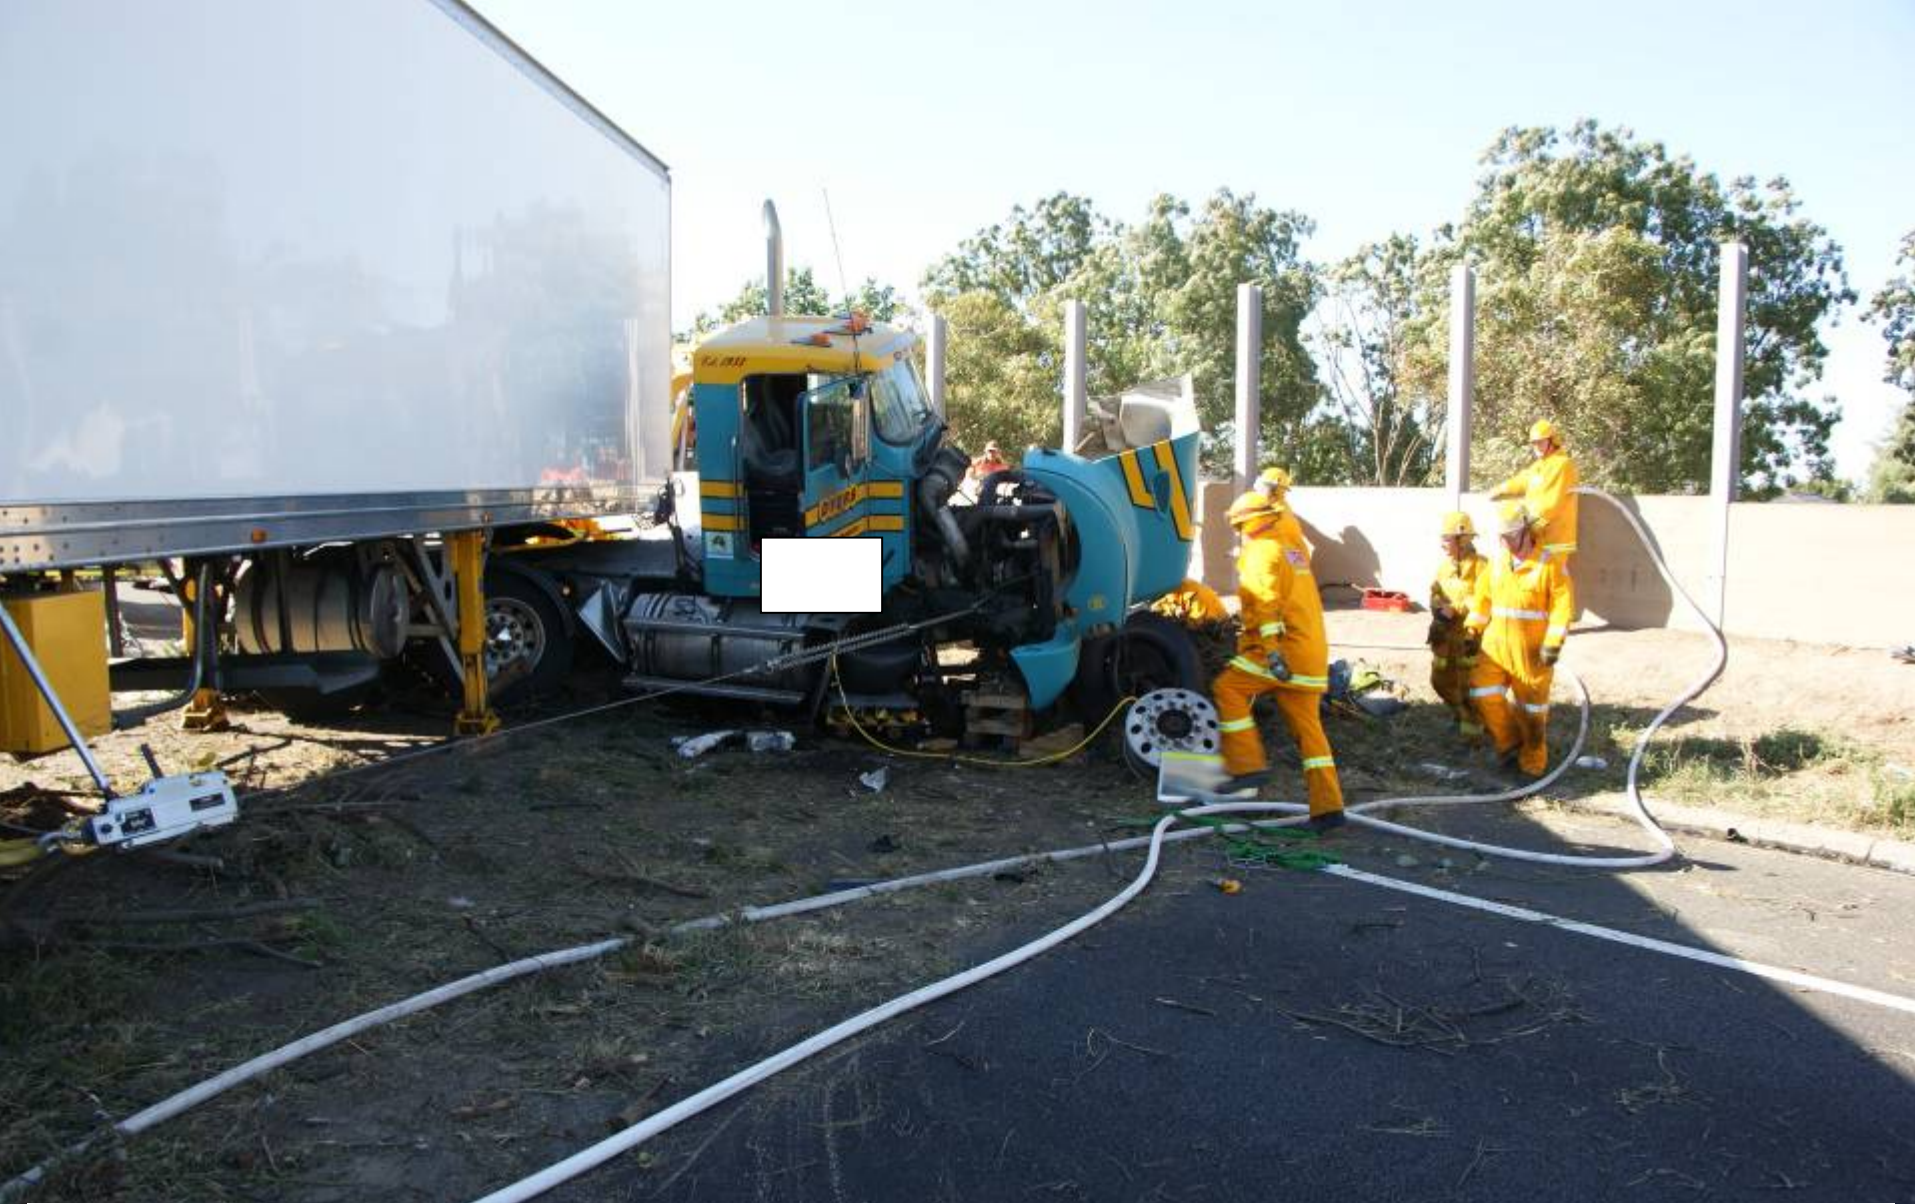
The truck moved with the car when it was being winched, so the truck was held by the tirfor winch back to the trailer

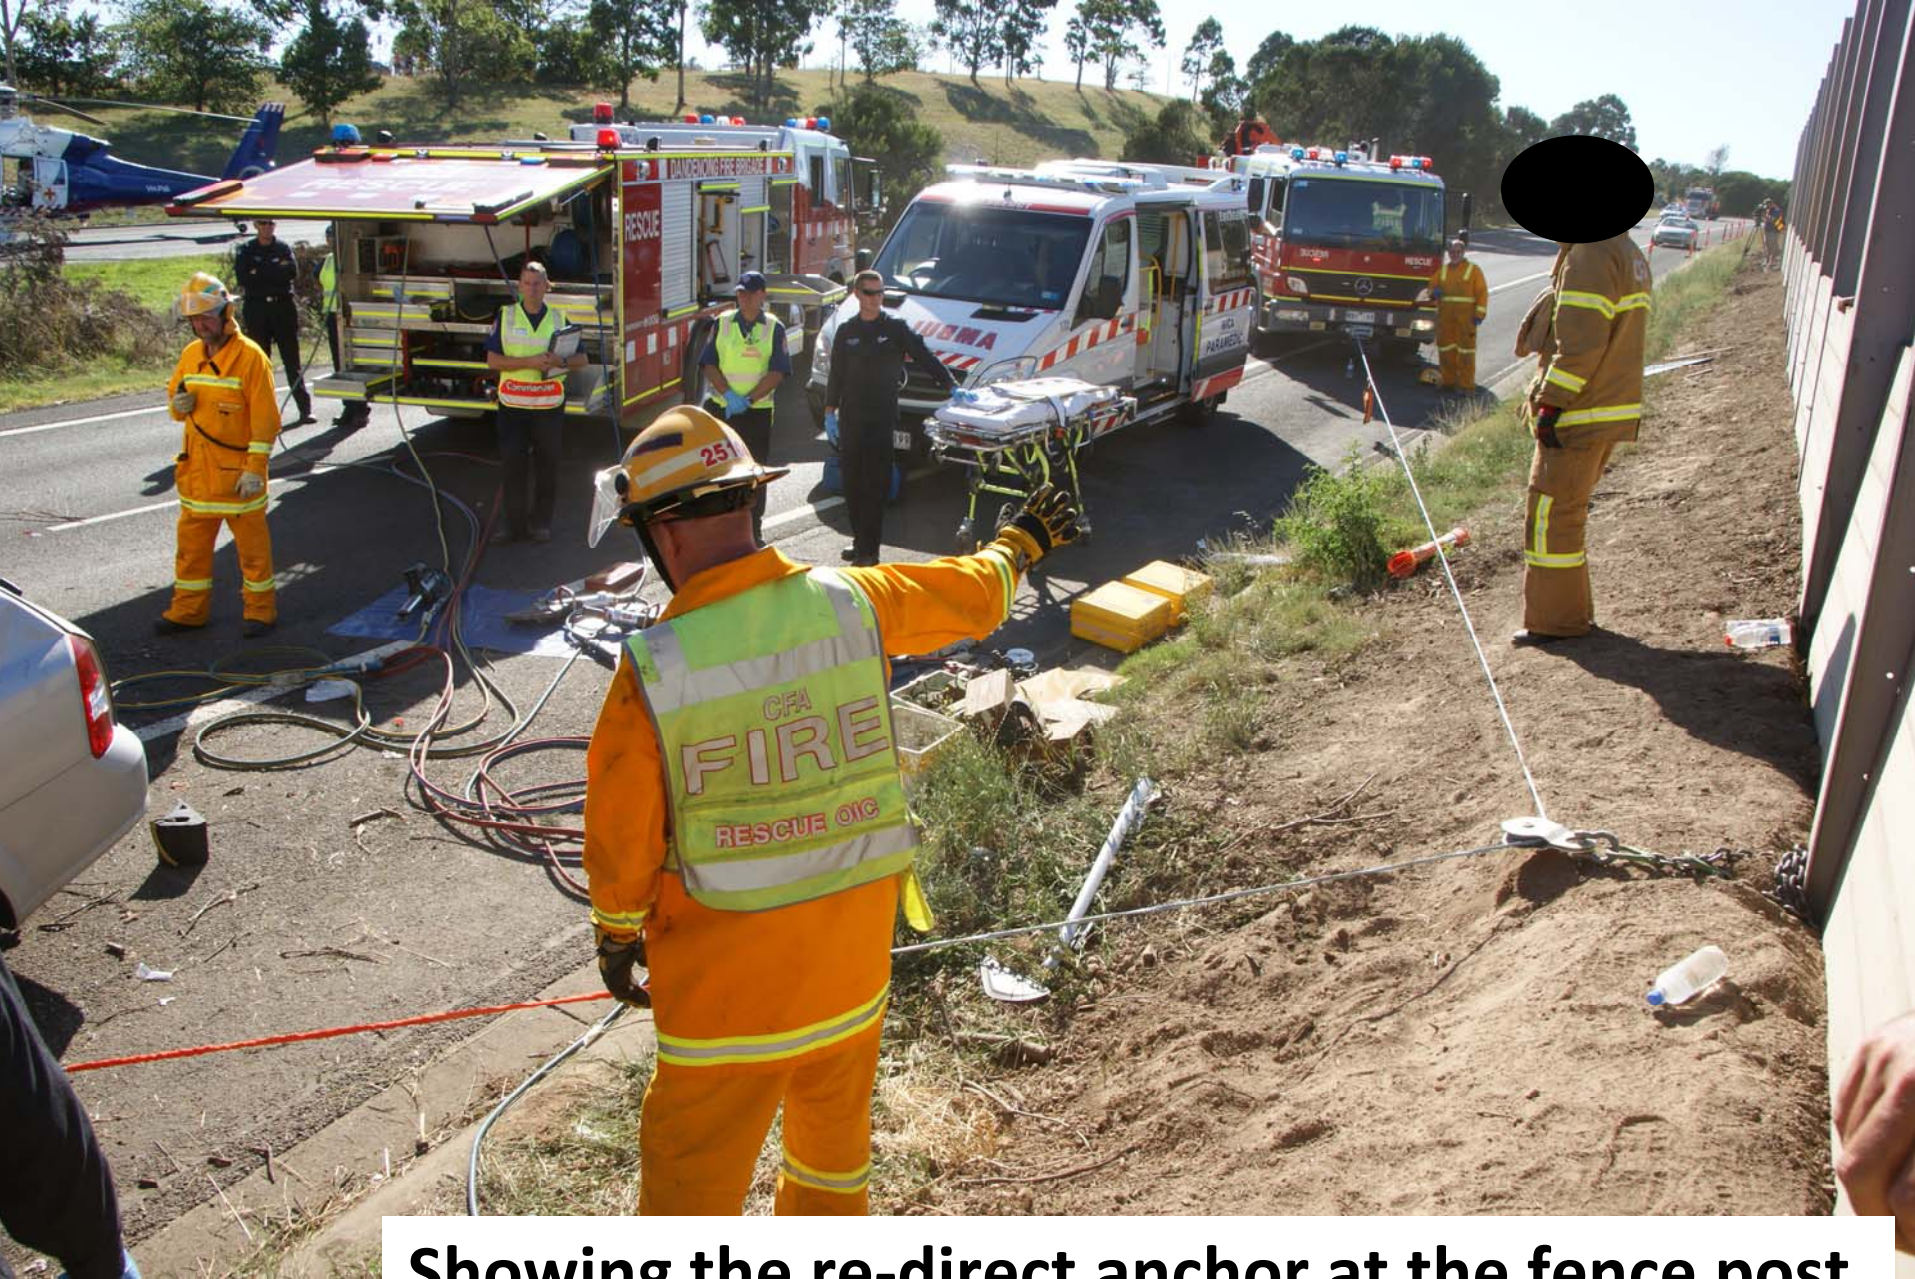
**Showing the re-direct anchor at the fence post.
It was 3 feet into the ground**

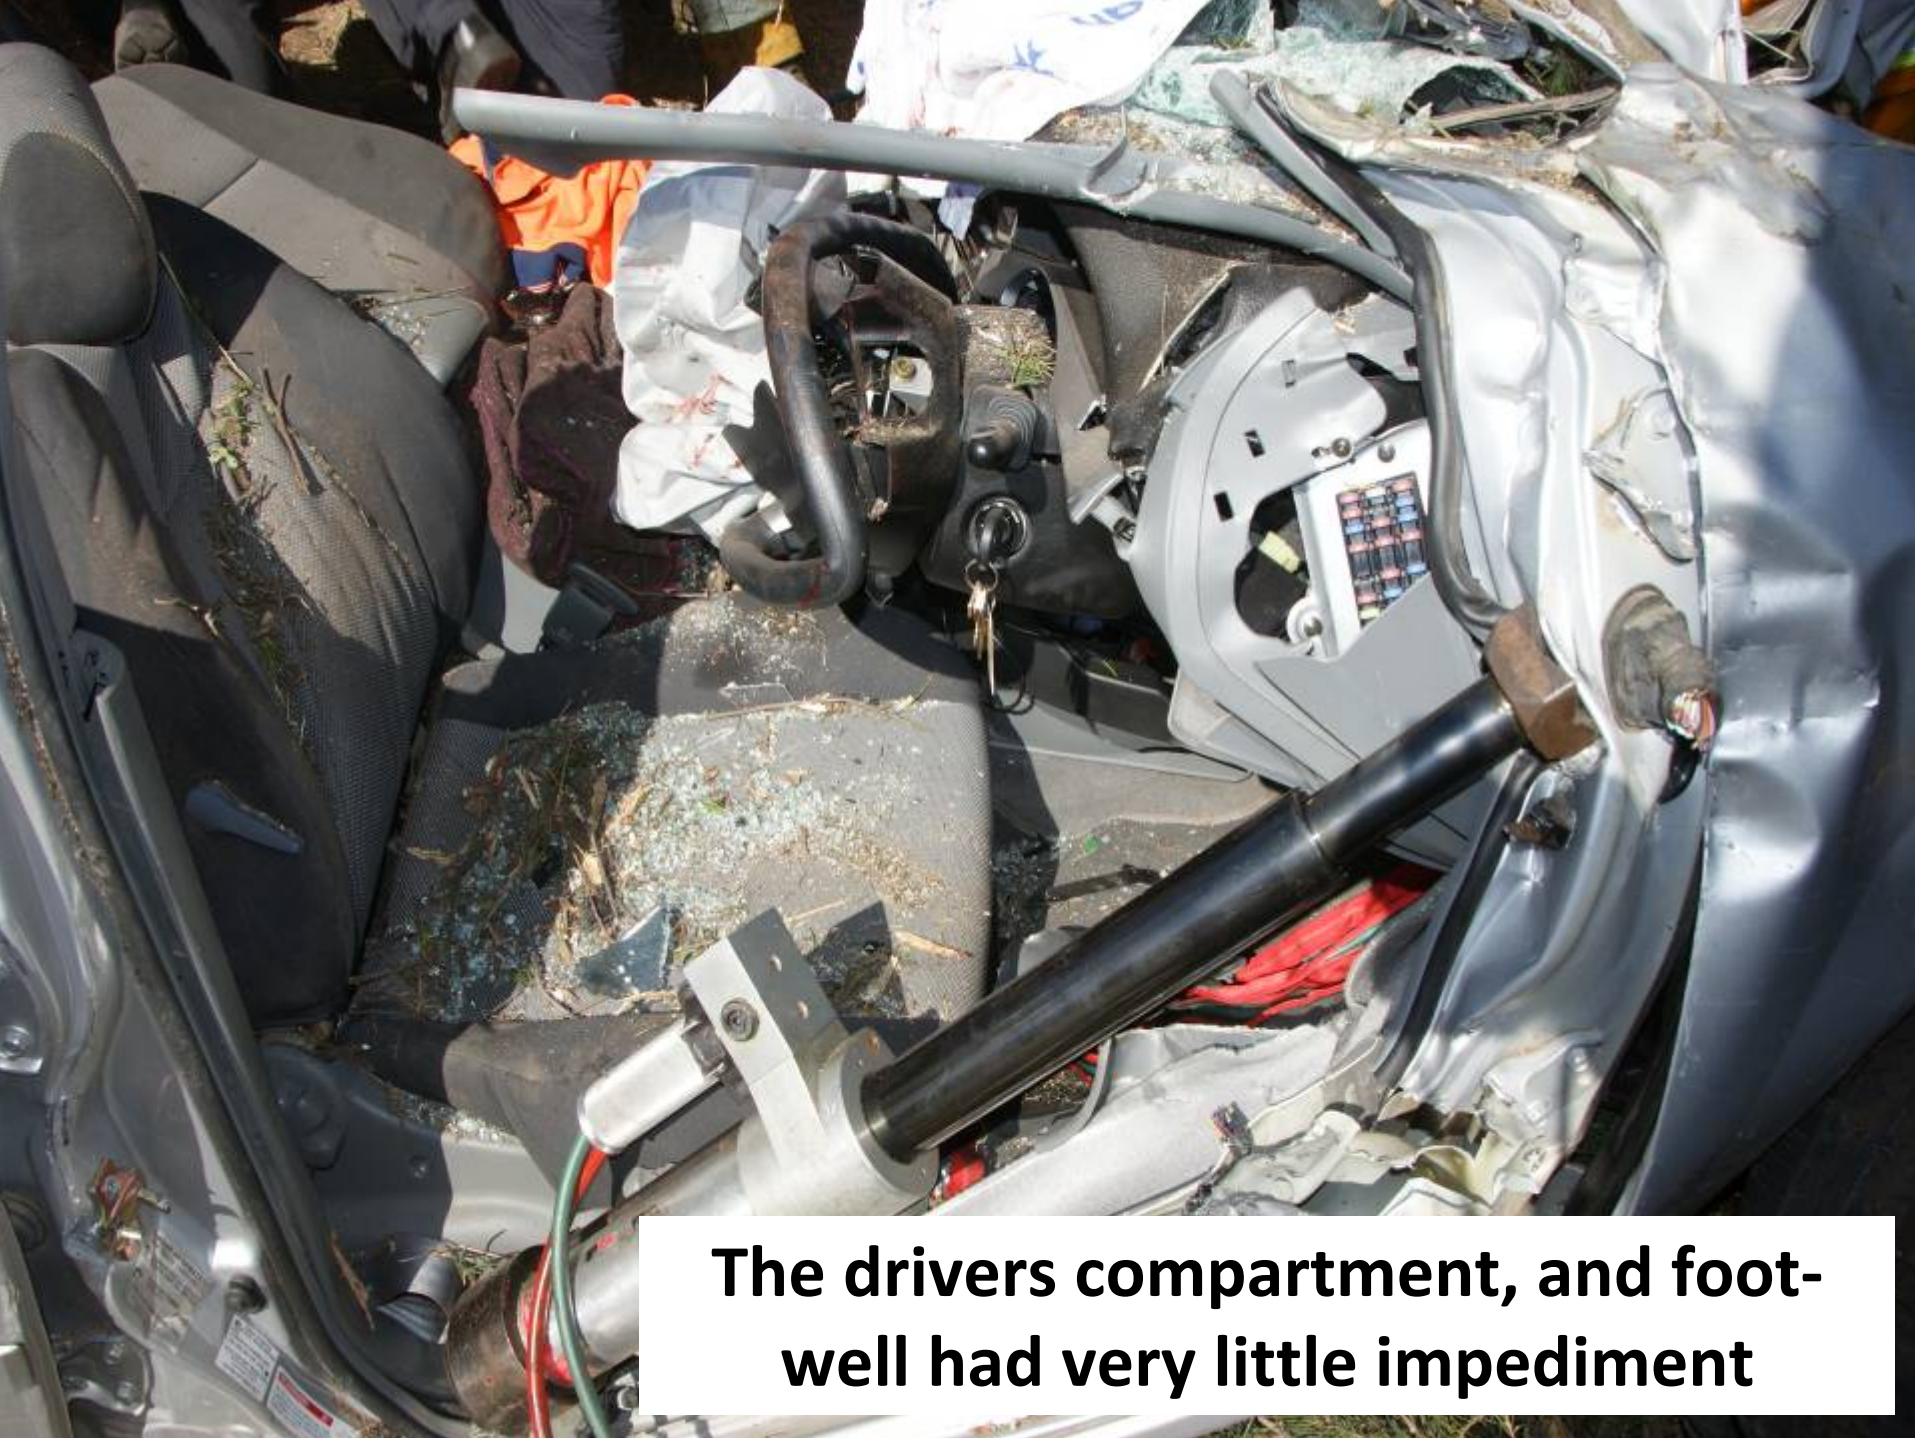
The drivers compartment, and footwell had very little impediment
