Structural Anatomy™

Operational Safety at Deconstruction and Demolition Sites

Awareness and Operational Considerations Briefing

The Deutsche Bank Building

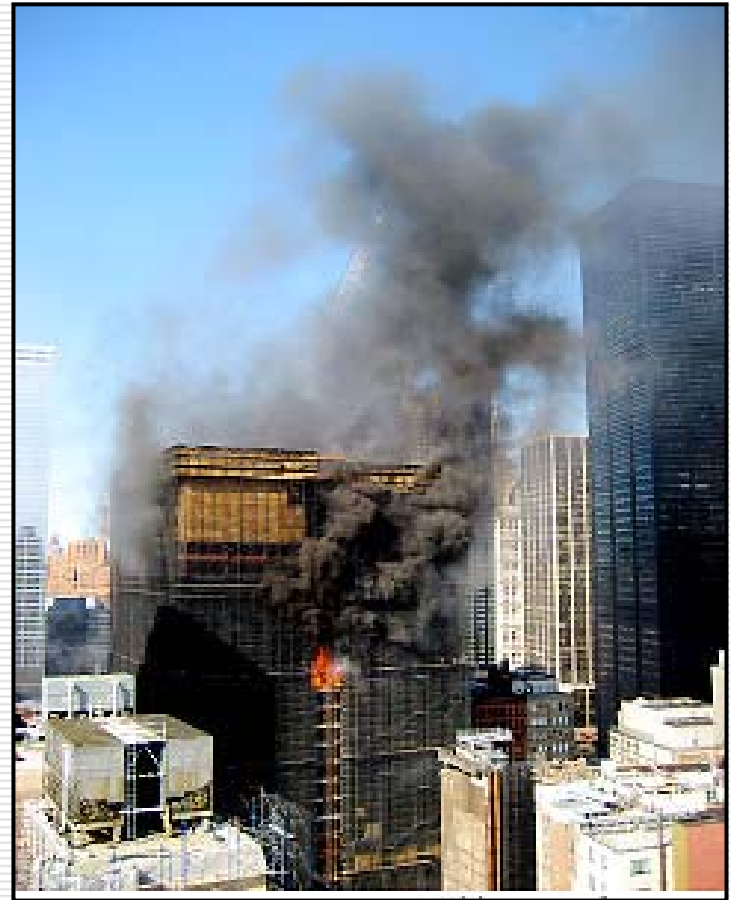
- ❑ Located at 130 Liberty Street adjacent to quarters of FDNY Engine 10, Ladder 10
- ❑ Once a 40-story high-rise structure- systematically reduced to 26-stories at the time of the fire.
- ❑ Significant building contamination from numerous toxic substances including asbestos and lead resulting from the destruction of the World Trade Center during the 9/11 attacks
- ❑ Required the deliberate floor-by-floor dismantling effort as part of the deconstruction process that would ultimately remove the building from its present site.

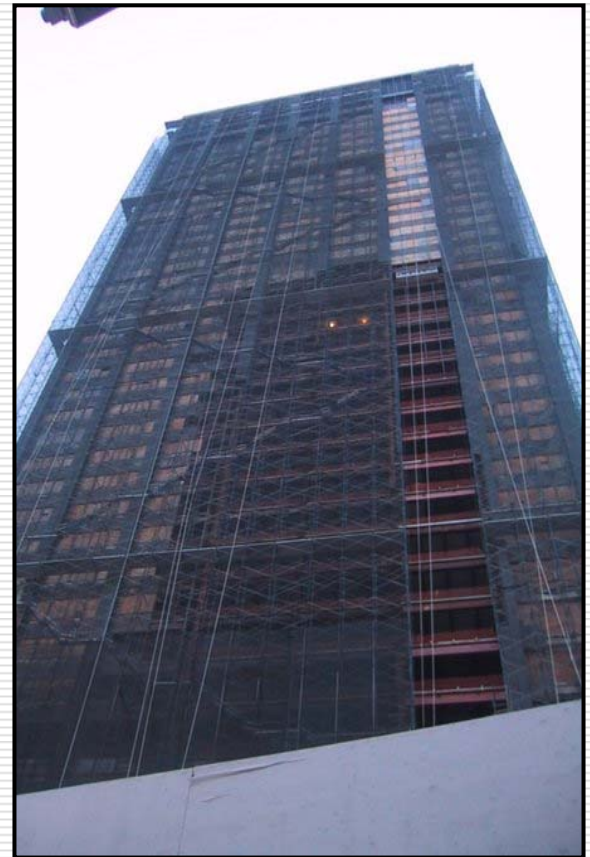
Deutsche Bank Deconstruction

- ❑ The fact that the Deutsche Bank building was being dismantled floor by floor- that it was undergoing **"Deconstruction"**
- ❑ The building was a primary **target hazard** containing significant operational vulnerabilities, hazards and dangers posing life threatening risk to unsuspecting firefighting personnel.
- ❑ Building undergoing **asbestos abatement** further compounds the degree of risk present.

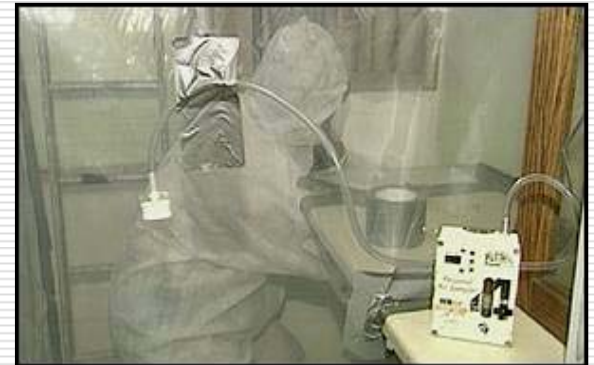
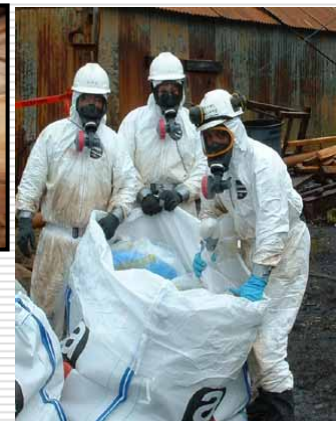
- ❑ Deconstruction; the high-rise steel frame structure was being systematically dismantled from the top down.
- ❑ Structural assemblies, systems and components were being removed as part of the asbestos abatement and decontamination efforts, creating varying levels of system integrity, exposures and vulnerabilities.
- ❑ Various deconstruction stages throughout the building created exposed structural systems, building components and features that posed significant safety risk to personnel.
- ❑ The building's exterior was shrouded in a scaffolding system, with limited accessibility and travel volume. Unprotected external scaffold support systems present.
- ❑ Asbestos Abatement Plans created; Abatement Zones, Buffer Zones and Deconstruction Zones- Each with significant operations risks and hazards.

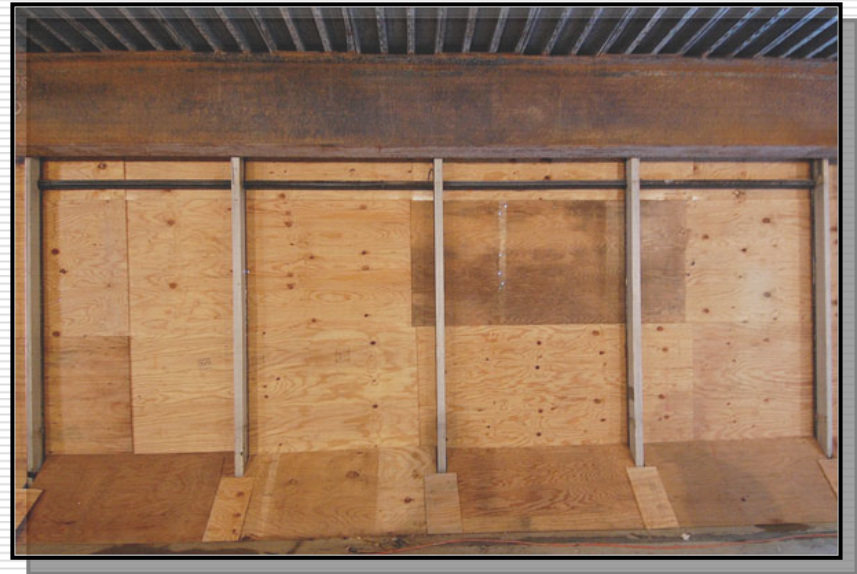
Challenges...

- ❑ Interior abatement zones were constructed that created undefined and maze-like conditions.
- ❑ Enclosed exterior window walls that were replaced with plywood sheathing creating impenetrable enclosures, limiting egress paths, ventilation paths and providing susceptible fire loading and flame spread potential.
- ❑ Introduction of significant transient combustible loading, i.e., plywood sheathing and panels, poly sheeting and plastics and other Class A materials

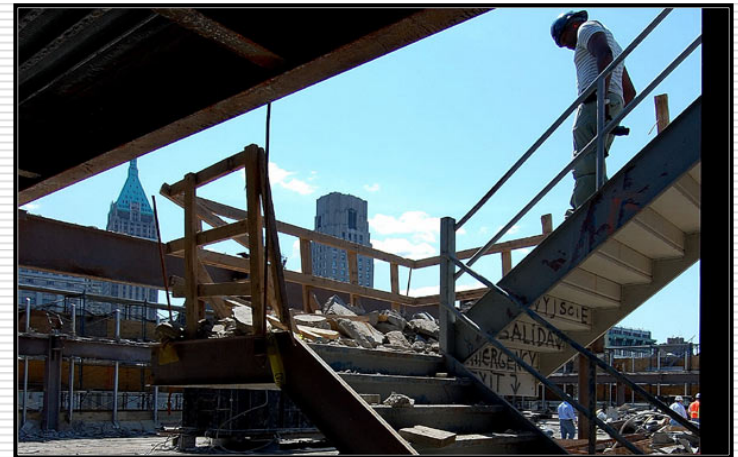
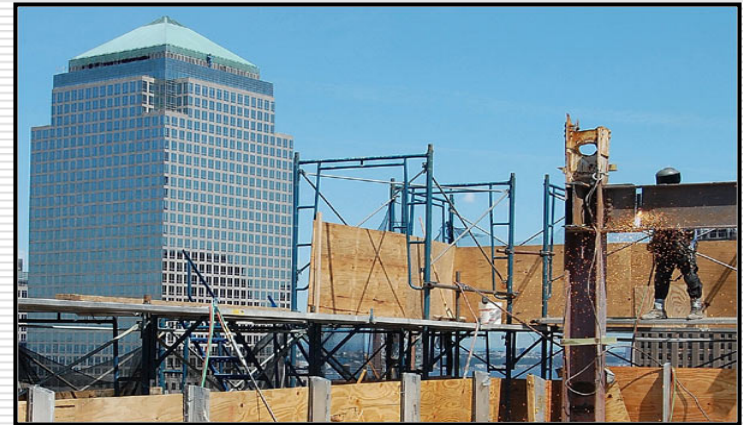
Hazards....

- ❑ Access and egress systems were changed or removed.
 - Stairwells were eliminated, boarded-up or enclosed.
- ❑ Compartmentation, enclosures, fire separations and fire barriers were compromised, dismantled or removed,
 - creating undefined open areas, horizontal and vertical voids, plume ways and travel paths.
- ❑ Officials state that in addition to the non-functioning stand pipe, fighting the fire was made difficult by the asbestos abatement, which created "maze-like conditions."
 - Many areas were partitioned off with plastic, and hallways and walls one would find in other buildings had been torn out.
 - Workers told officials they had been stripping asbestos from beams, and the fire spread quickly through gaps and holes in the structure.

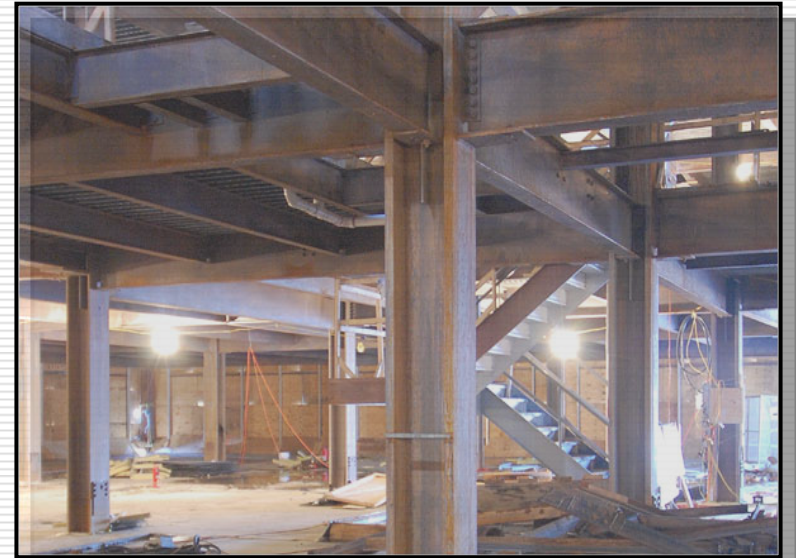
Risks....

- ❑ Designed active and passive fire protection and suppression systems, coatings, enclosures and features were in varying stages of removal, dismantling or non-functional.
- ❑ The fire standpipe system was non-operational, compromised and disconnected.
- ❑ The fire sprinkler system was non-operational
- ❑ There were no apparent controls of potential ignition sources: i.e., evidence of discarded cigarette butts in non-smoking areas.
 - The cause of the fire is presently under active investigation, though officials ruled out acetylene torches, which were not in use at the time of the fire by workers dismantling the building. Investigators are looking into whether the fire was started by a worker smoking, officials stated.

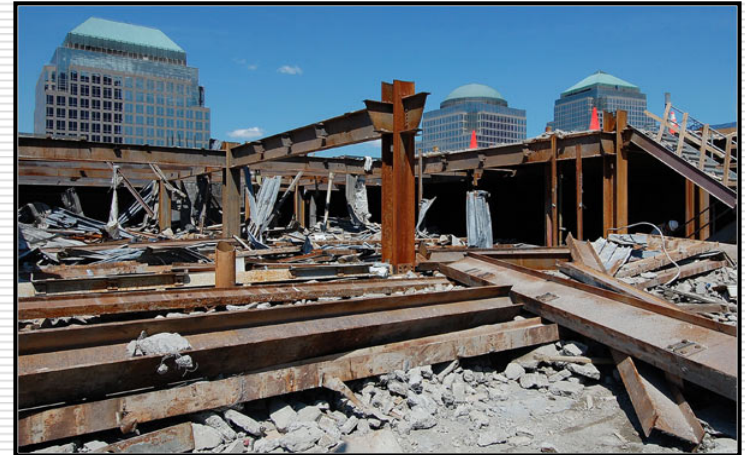
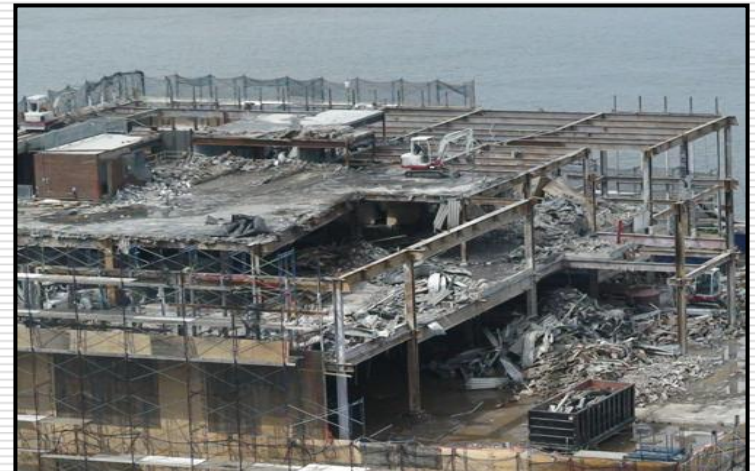
Precursors....

- ❑ Staging of compressed gas cylinders, flammable and combustible liquids; i.e. Acetylene, oxygen, oils, diesel and gasoline fuels etc.
- ❑ Temporary power distribution and lighting systems, devices and equipment
- ❑ Construction machinery, equipment, motorized apparatus, tools and devices.
- ❑ The state of the building, the asbestos abatement hazard and heavy smoke made conditions especially difficult for firefighters,
- ❑ Firefighters resorted to using ropes to haul hoses up from the street to support the fire attack.
- ❑ Getting out was no easier than getting in. Only one of the two construction elevators was working and could carry only five or six men at a time, sources said. Yet dozens of firefighters were inside.

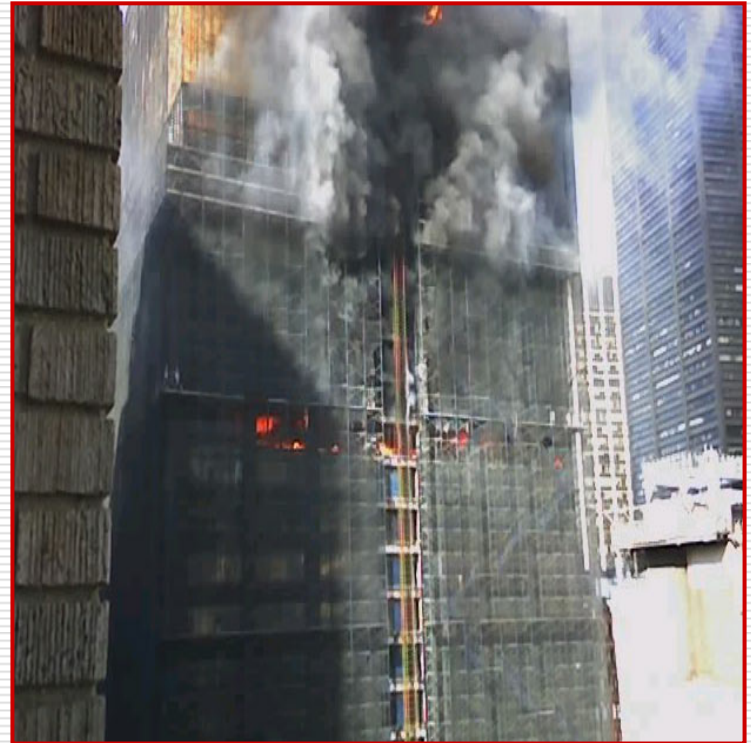
The Perfect Storm....

- ❑ Deconstruction work was halted for a week in May of 2006, when a 22-foot-long section of pipe fell from the 35th floor and went through the roof of the quarters of FDNY Engine 10, Ladder 10.
- ❑ It was determined at the time the subcontractor responsible with bringing the building down had little experience in bringing down large towers in urban settings
- ❑ The fire apparently started in the 17th floor according to workers who first reported the fire.
- ❑ The worst of the fire was on floors 14 through 19, but construction holes and vents created unchecked condition that allowed the fire to travel unabated up and down through the floors, igniting floors 20 through 26 as well.
